CORROCOAT EGYPT - Case study

Internal and external lining of Cation Exchanger Regeneration

Reference No.: 001PG_01_ref_vessel

Client: Amreya Petroleum Refining Company, Alexandria, Egypt

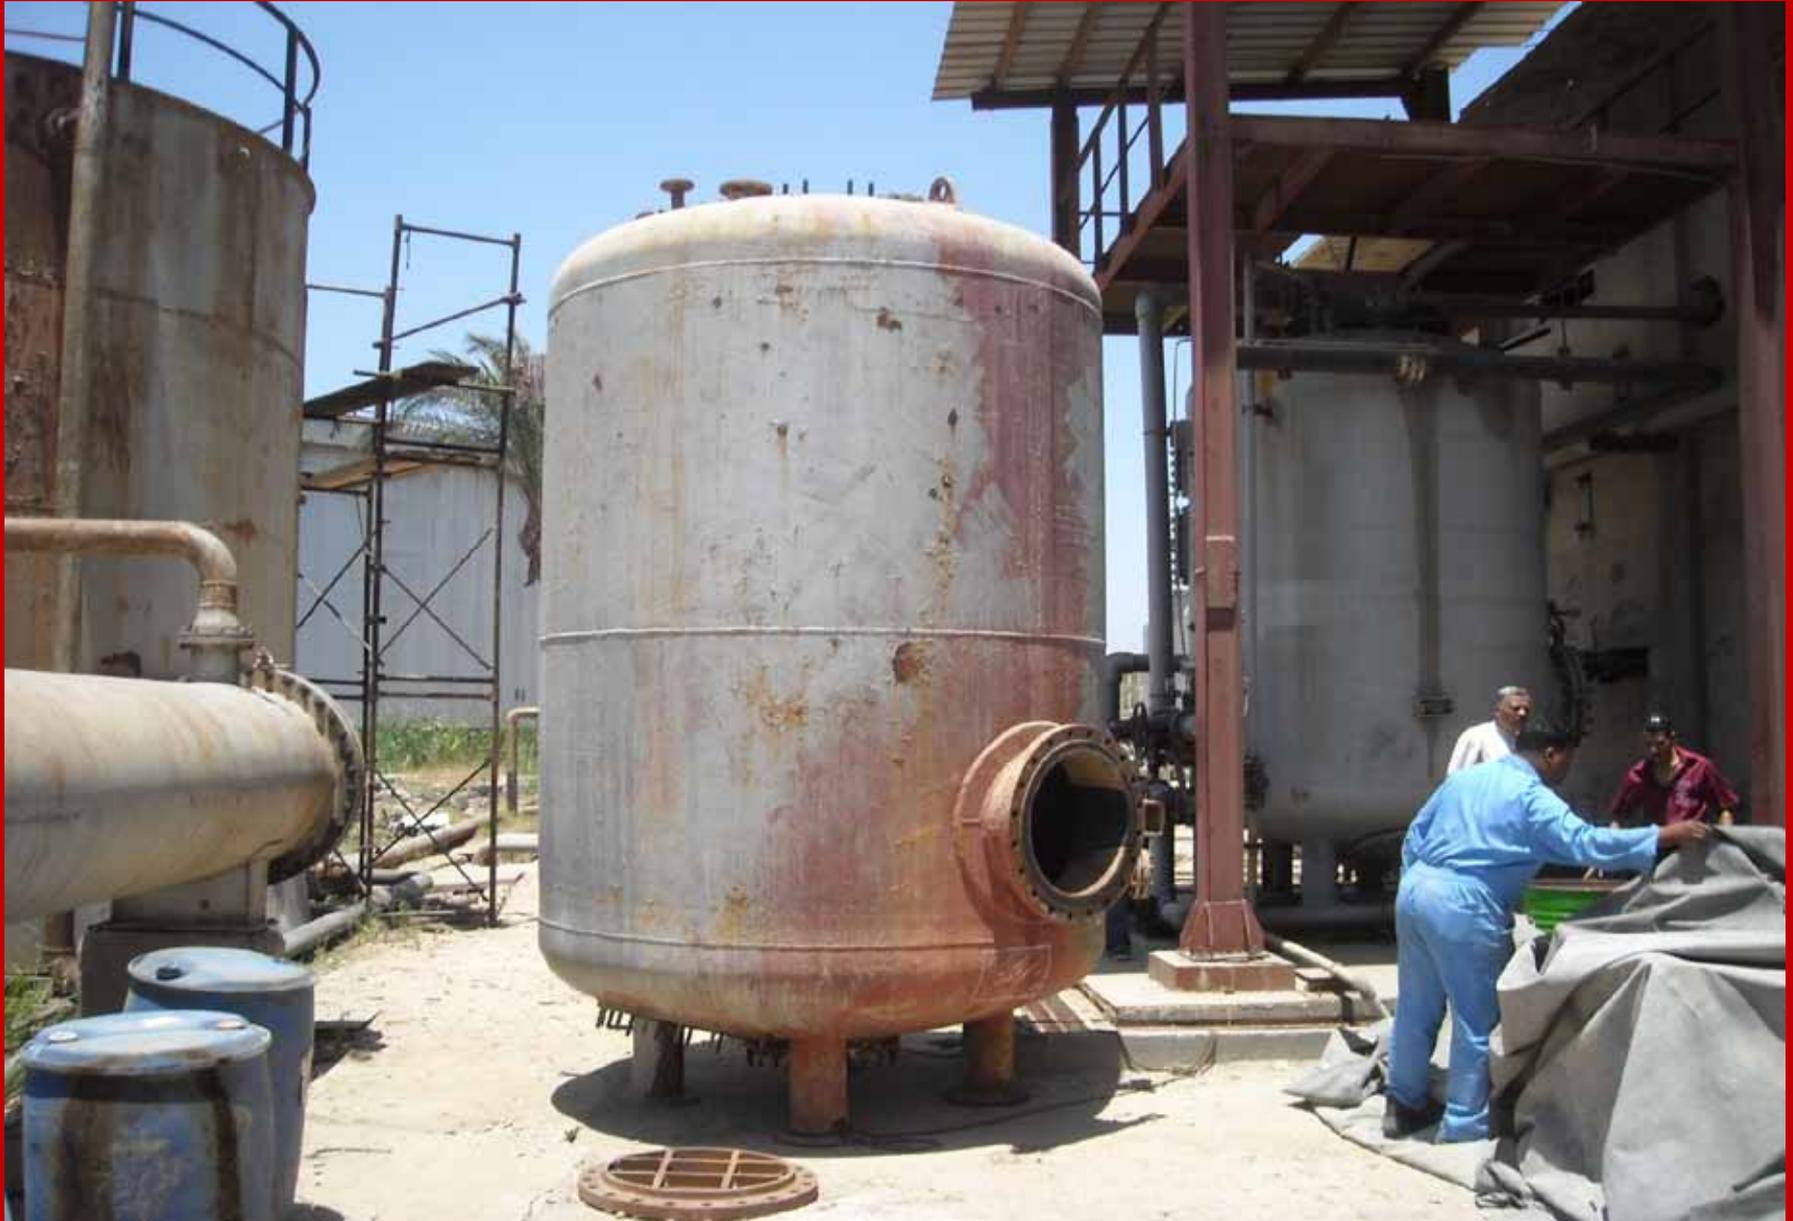
A.P.R.C. ANOMALY REPORT - under corroded hard rubber, vessel out of service

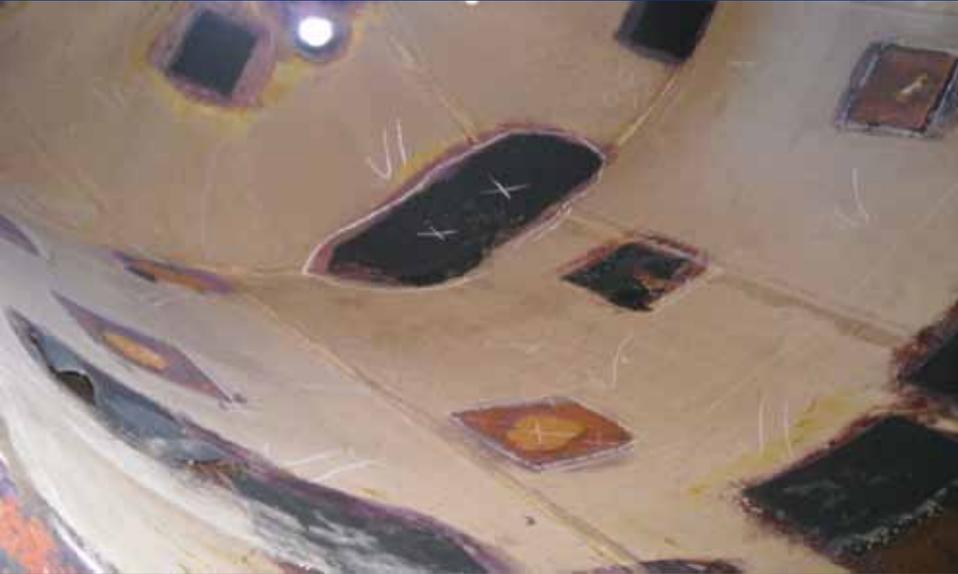
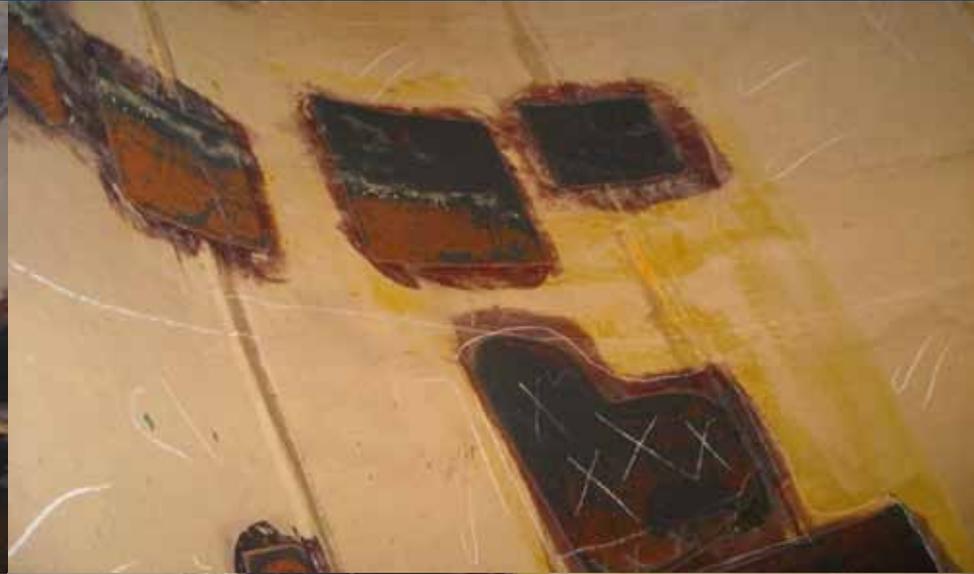
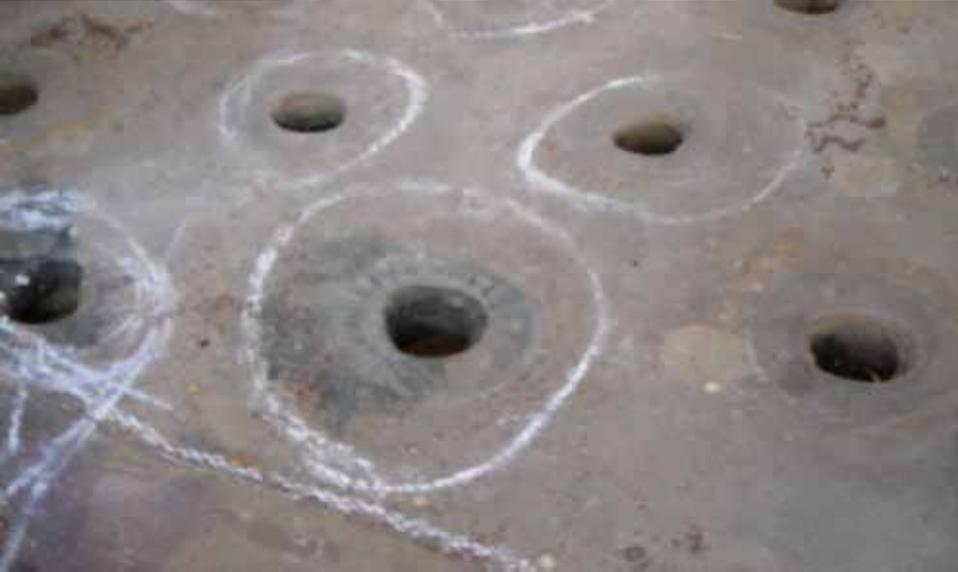
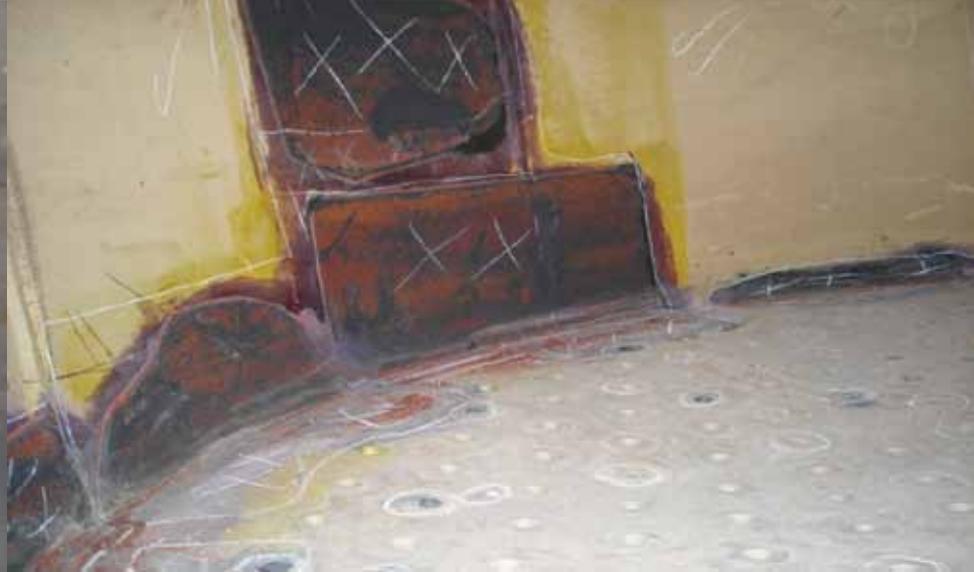
01 - CORROSION INSPECTION

Under corroded hard rubber lining and deep corroded areas (pitting corrosion)

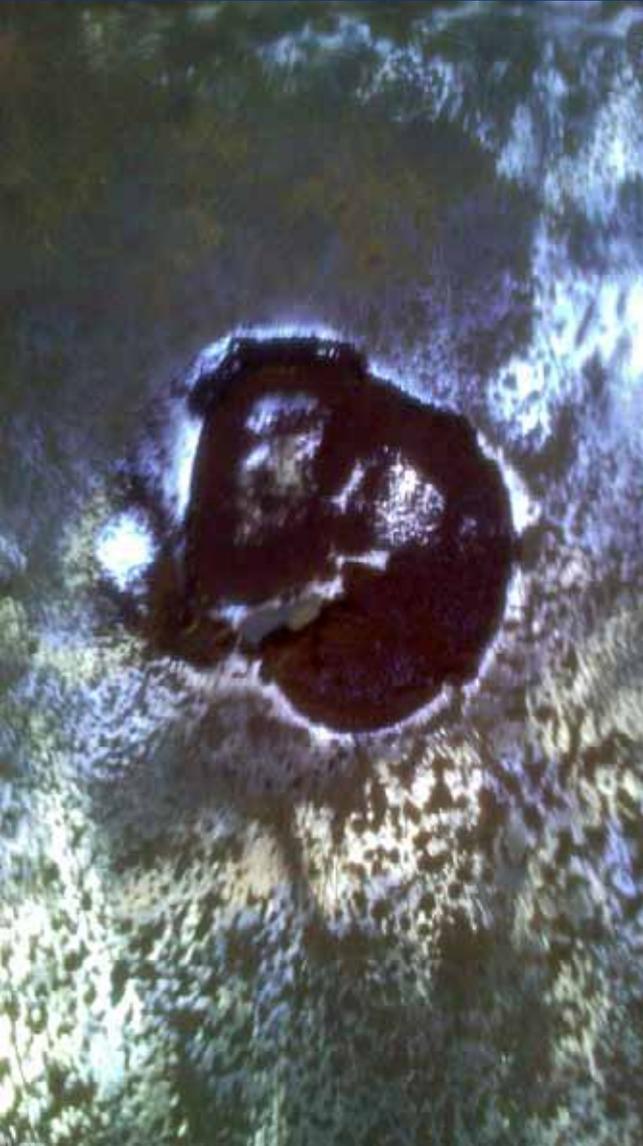
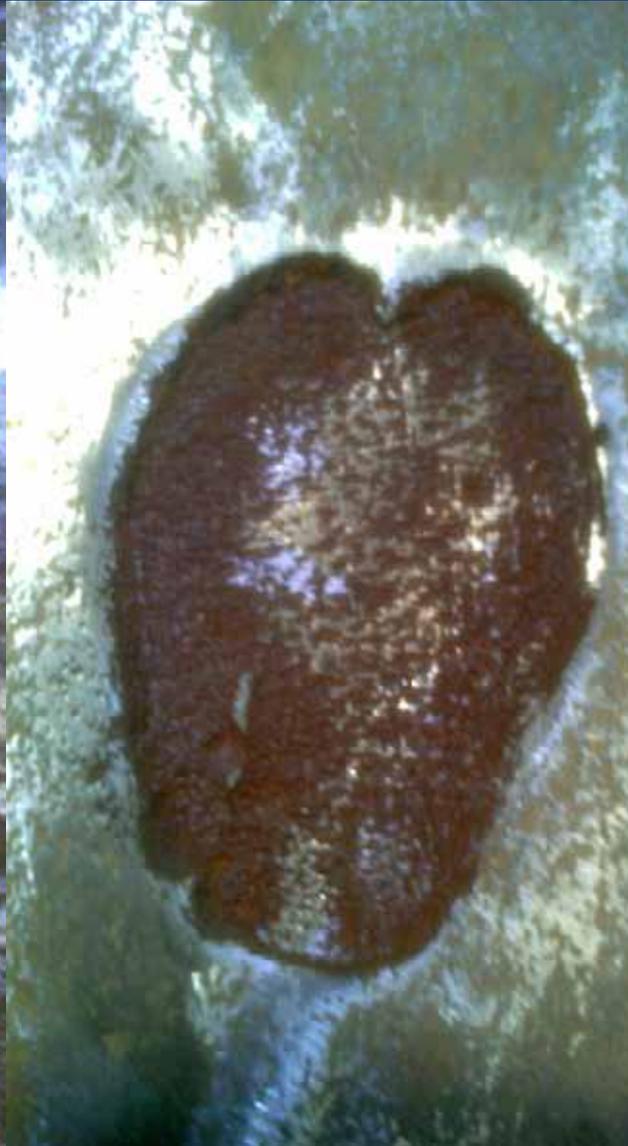
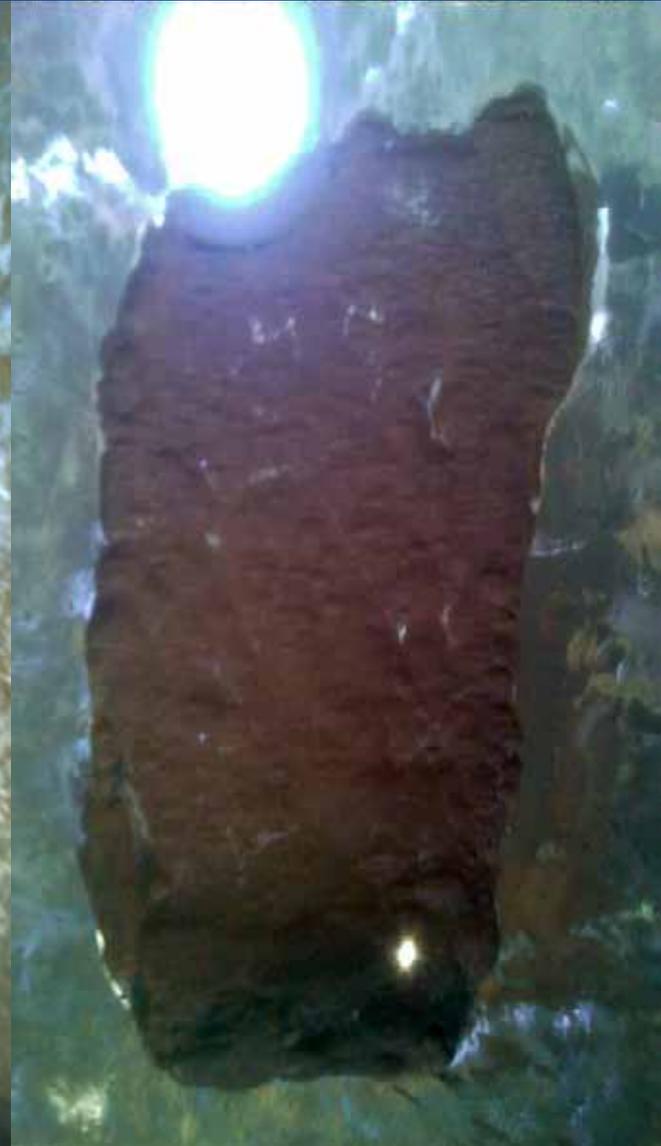
01 - CORROSION INSPECTION

Three very badly corroded areas

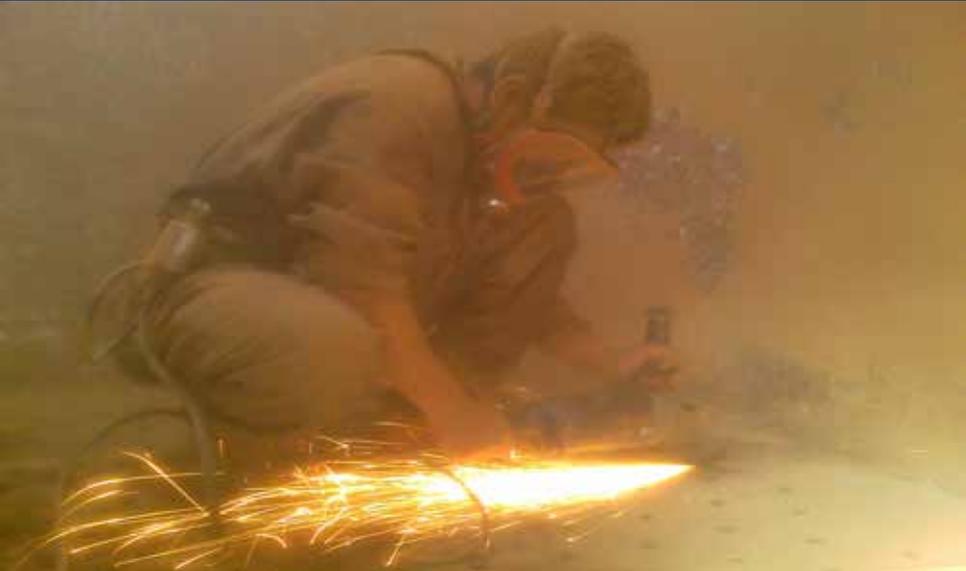
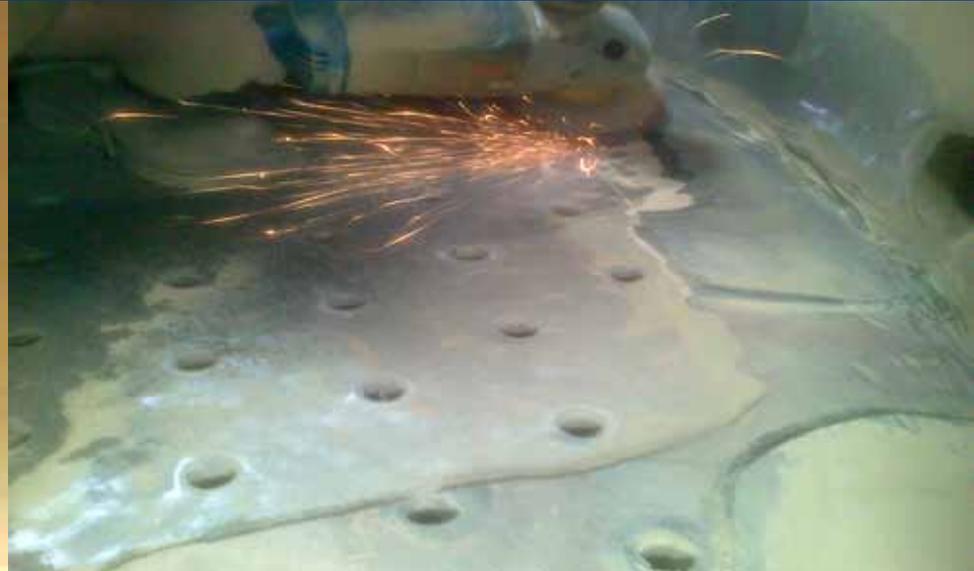
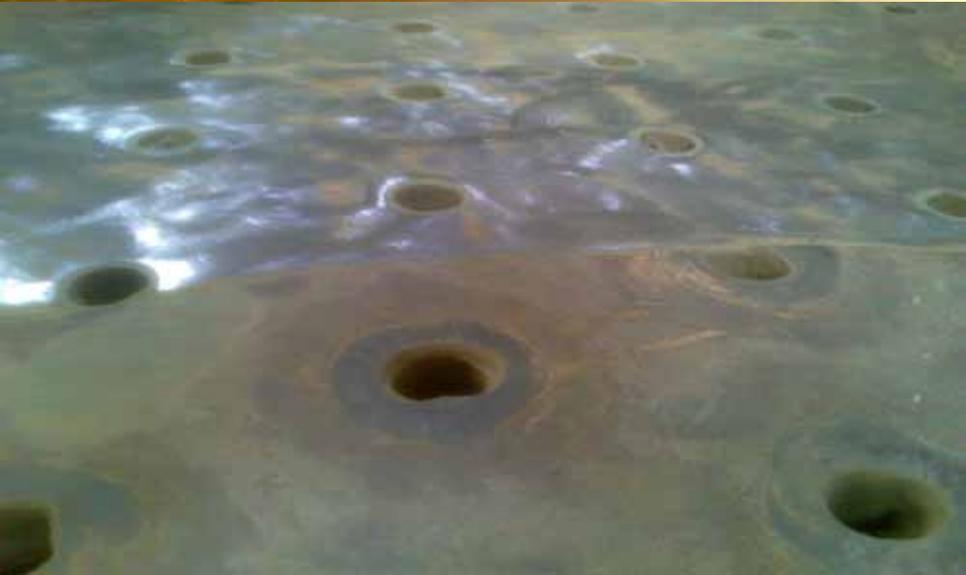
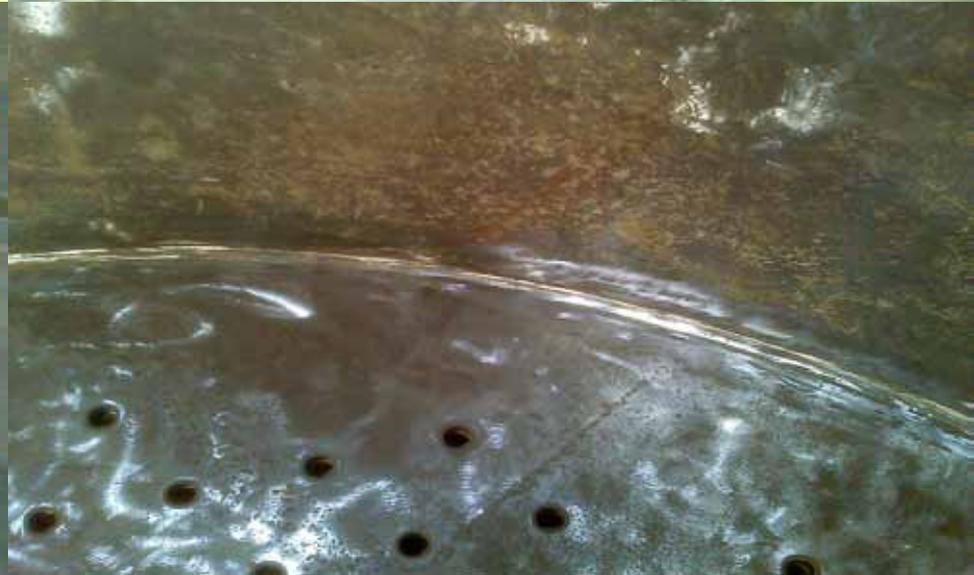
02 - SURFACE PREPARATION

Removal of hard rubber by grinding method

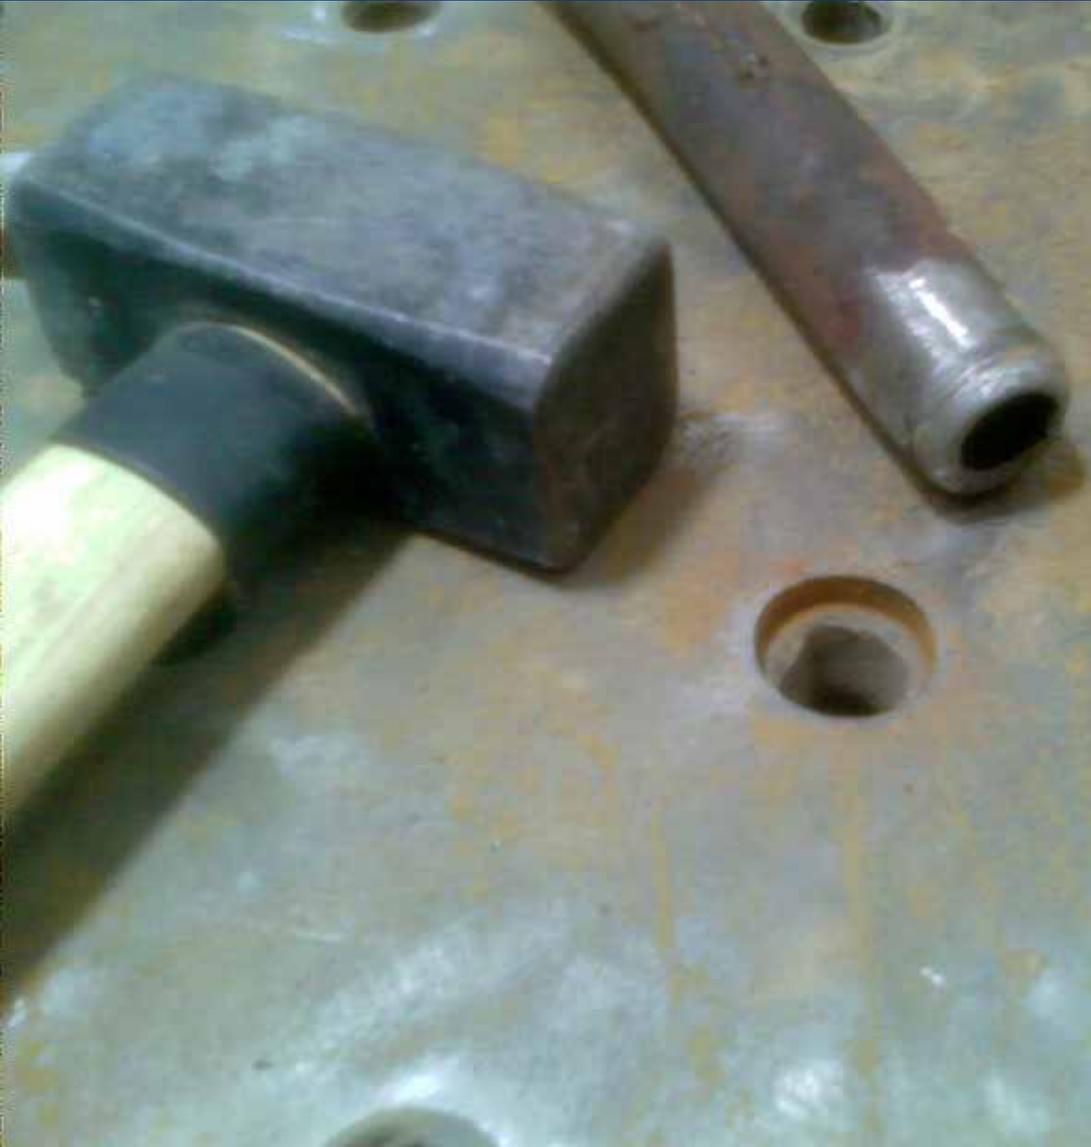
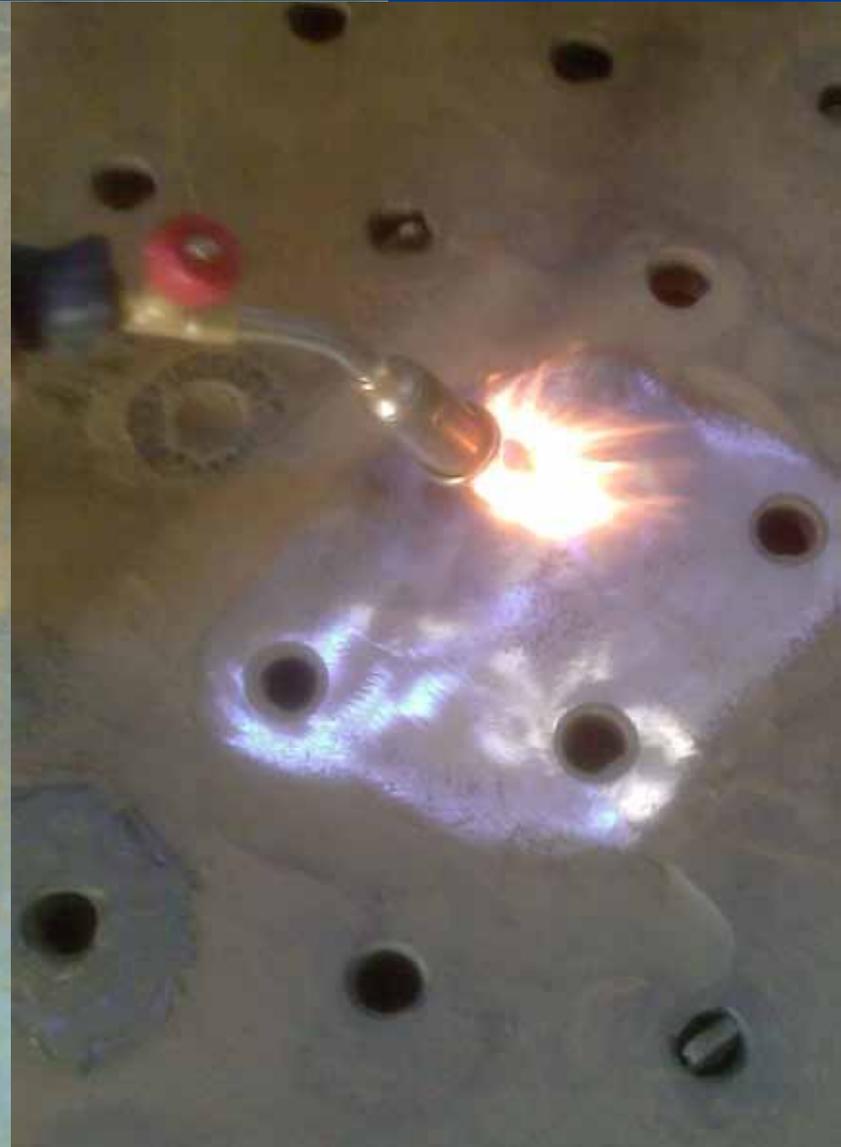
02 - SURFACE PREPARATION

Removal of hard rubber from 296 nozzle holes by hammering and burning method

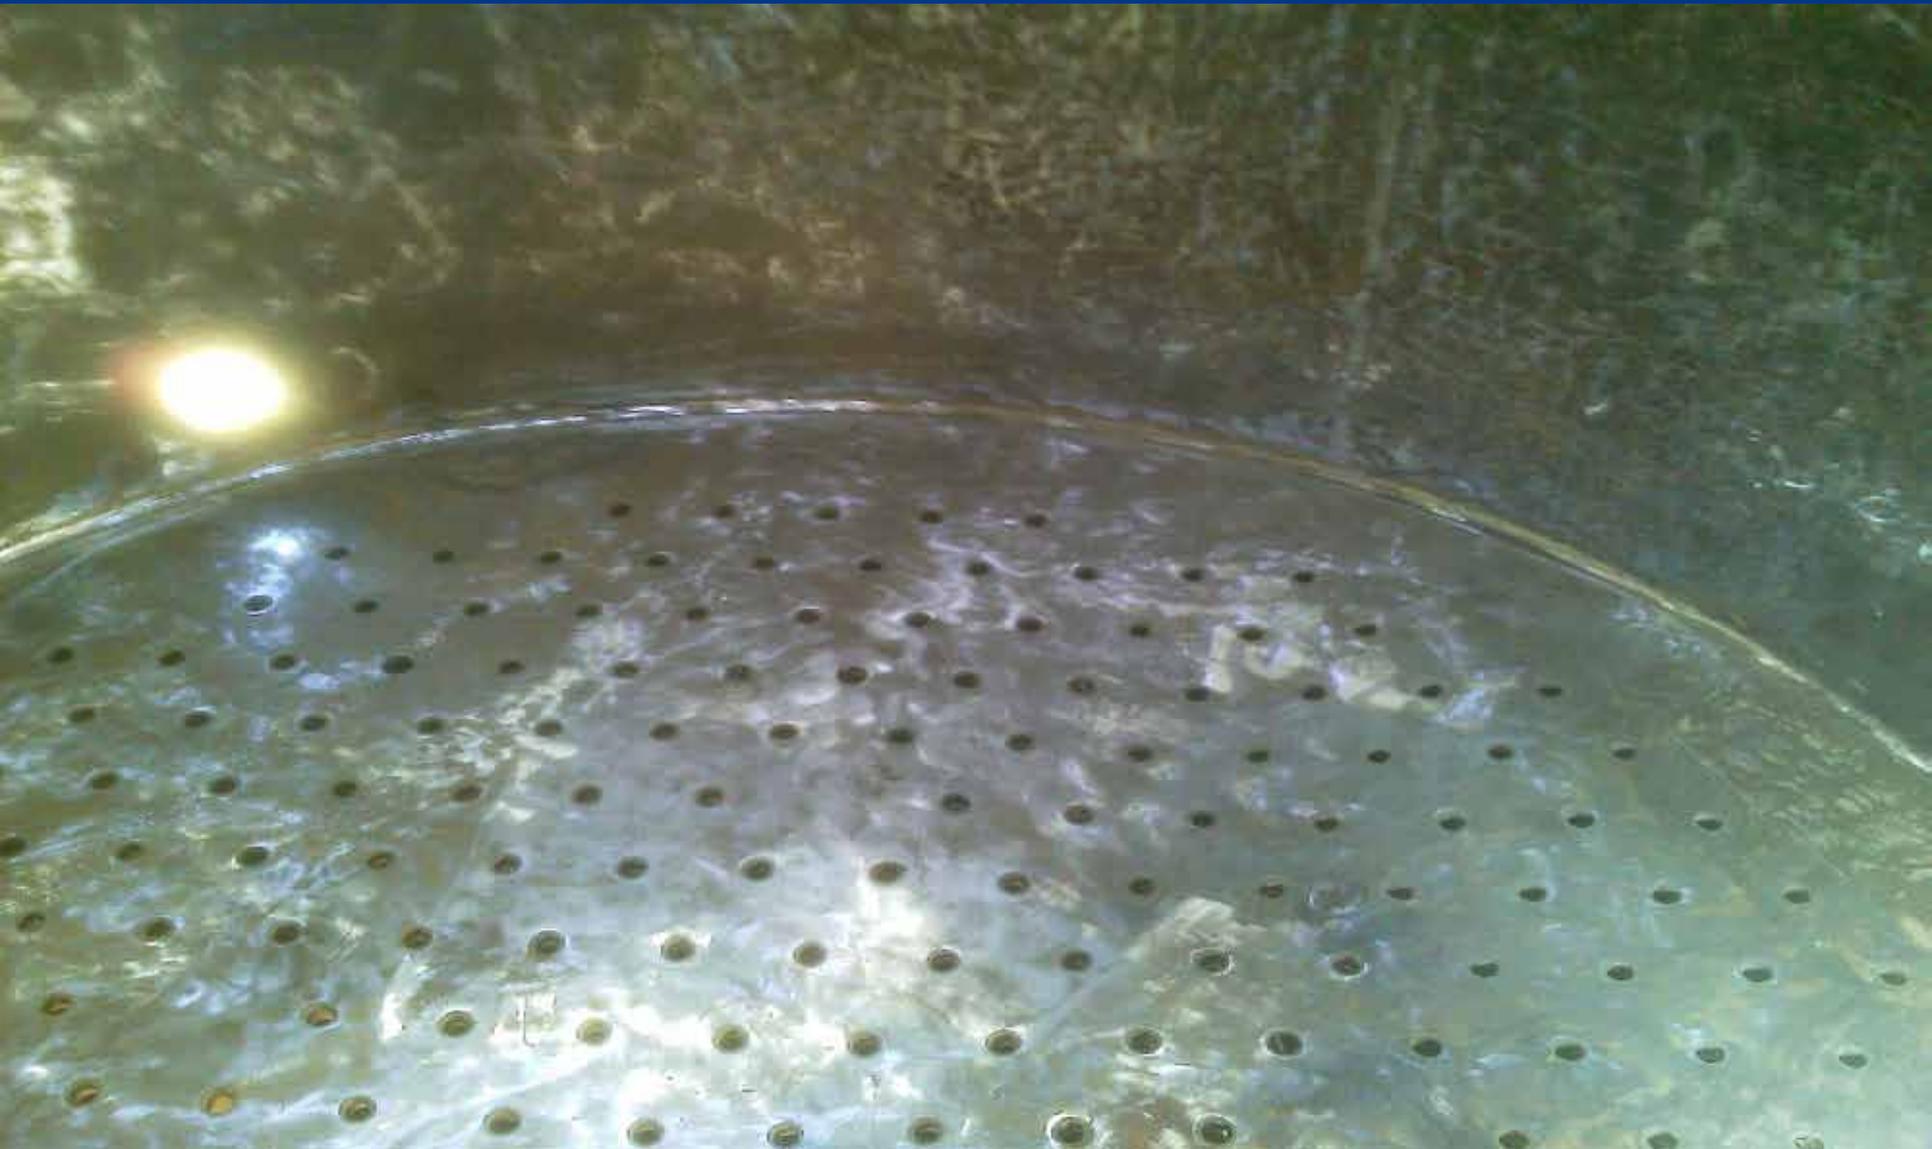
02 - SURFACE PREPARATION

Surface after hard rubber removal

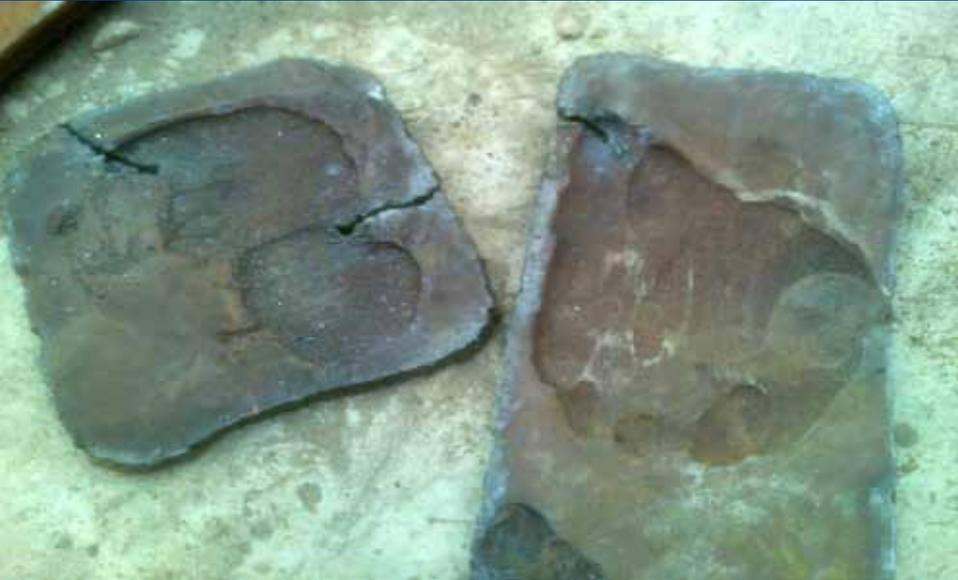
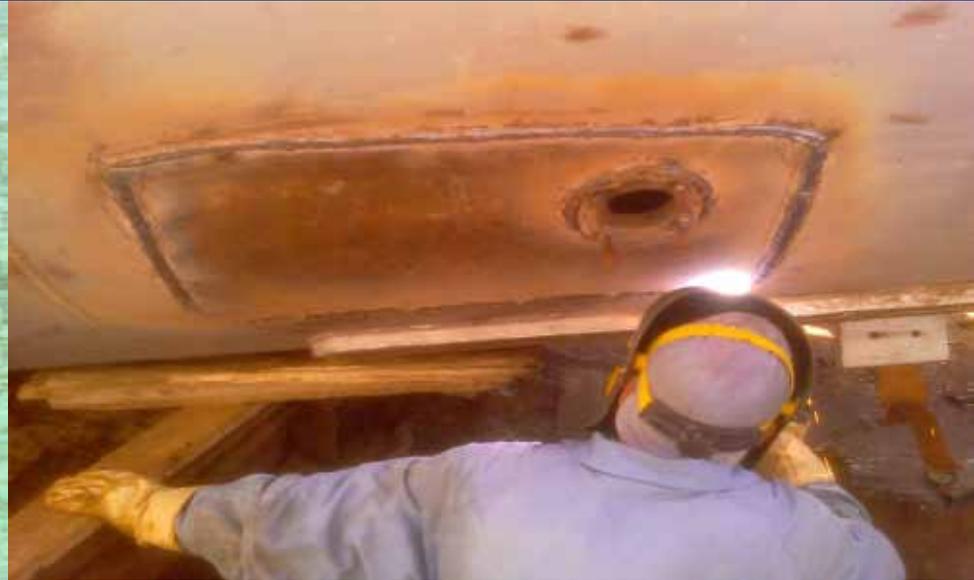
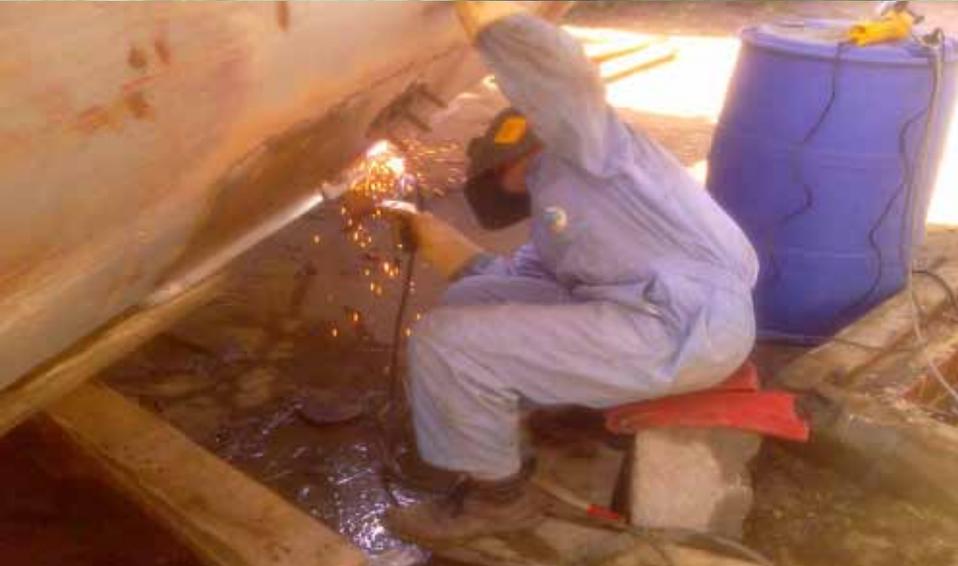
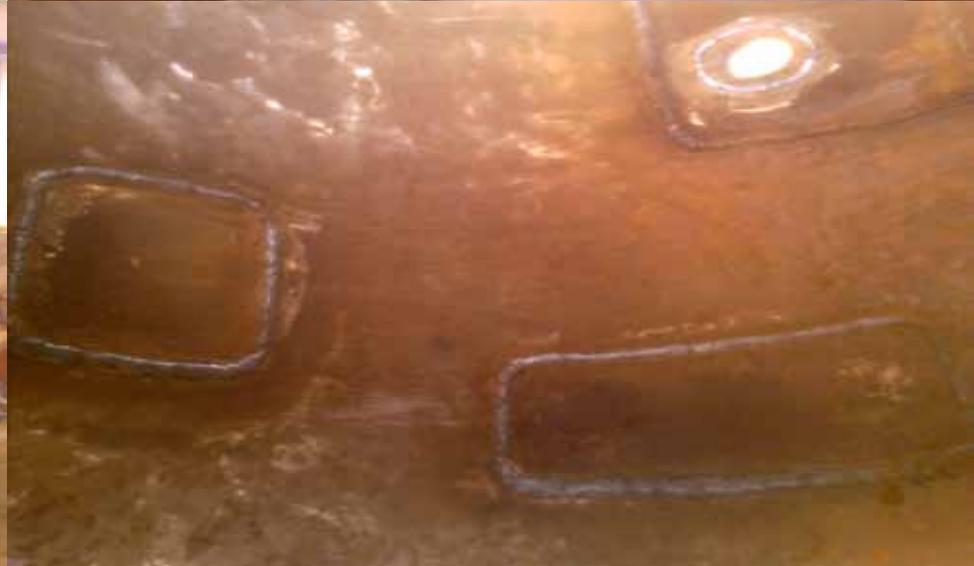
02 - SURFACE PREPARATION

Process of rewelding

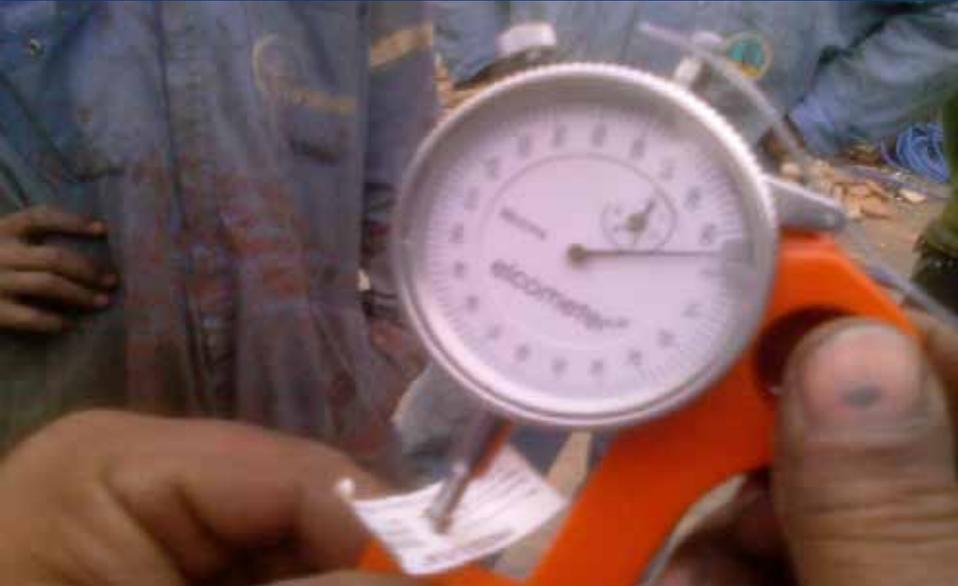
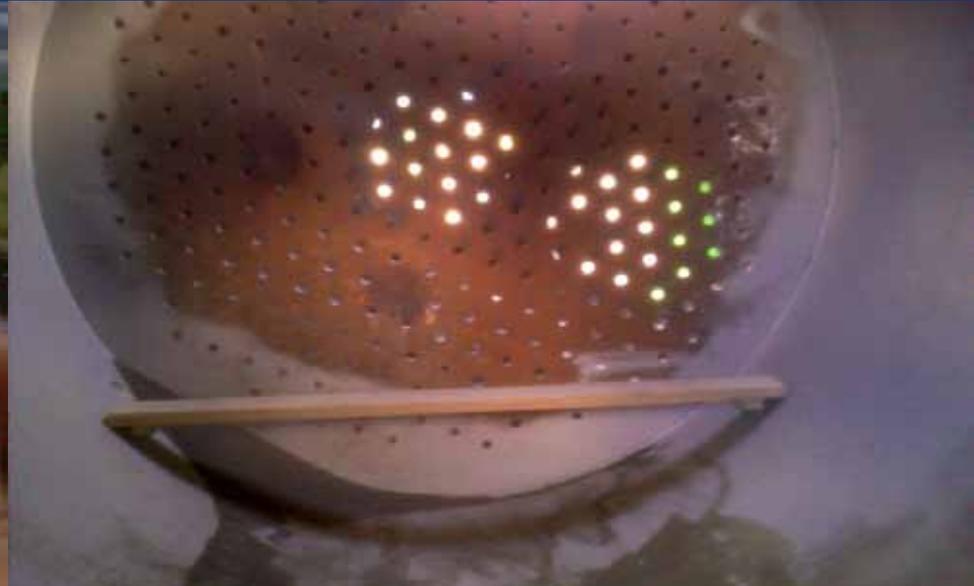
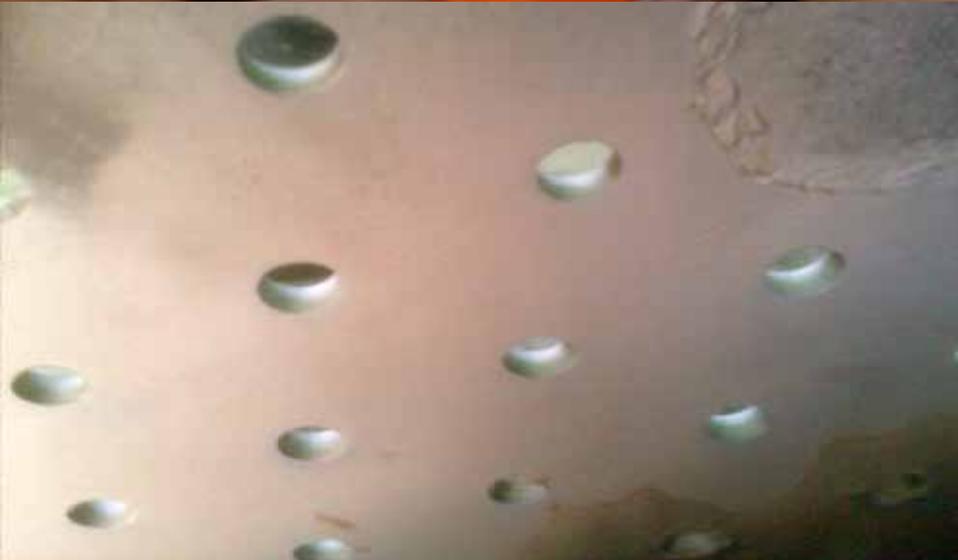
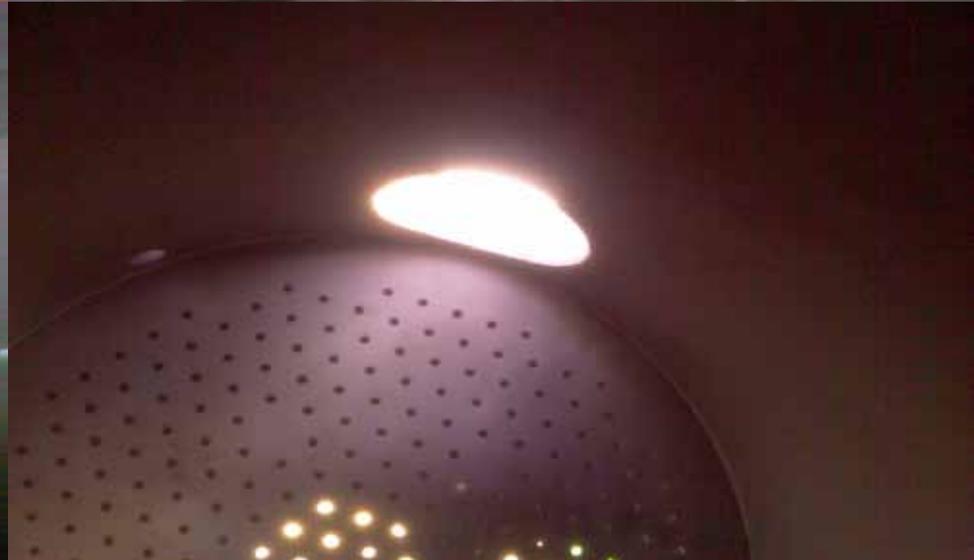
02 - SURFACE PREPARATION

Grid blasting to clean metal Sa2 ½ with profile roughnes min. 50 microns

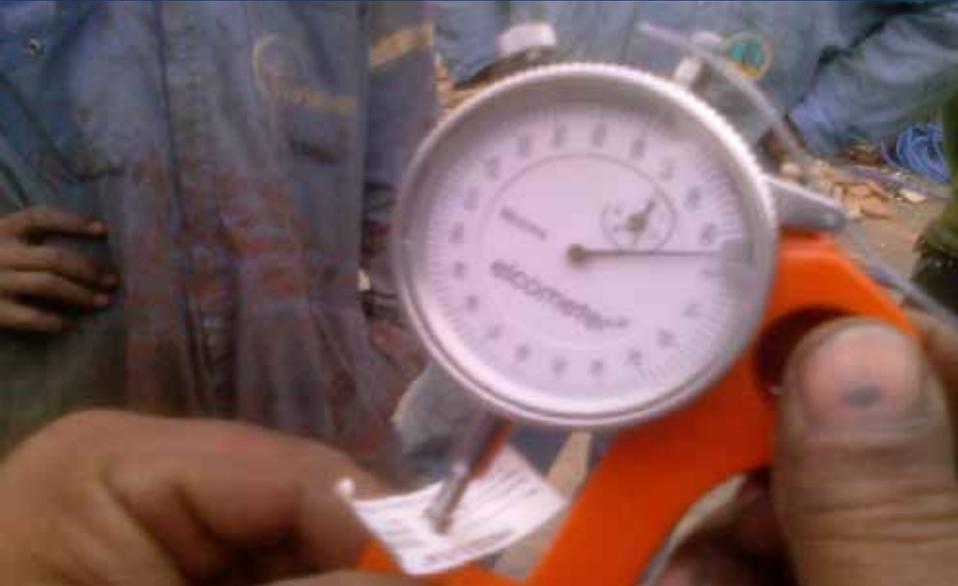
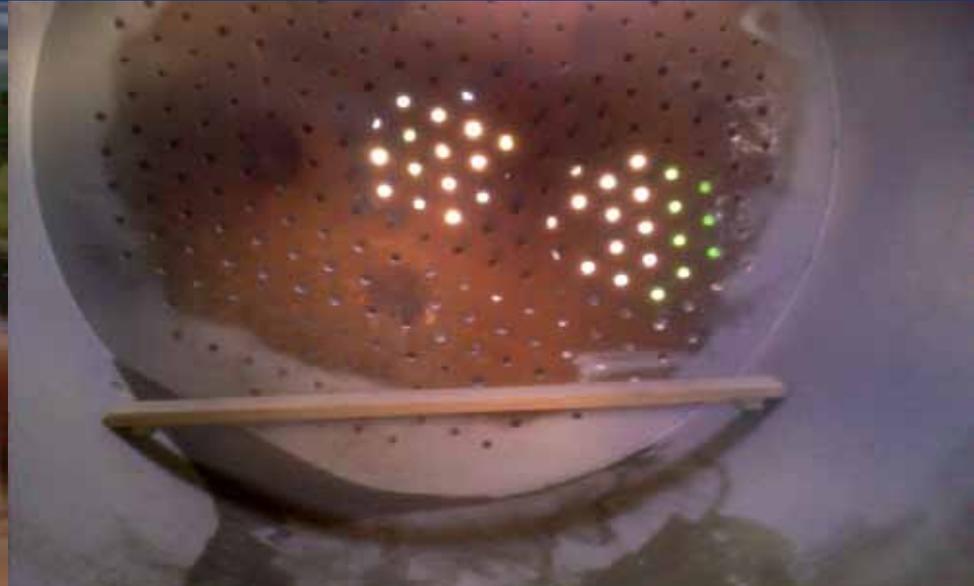
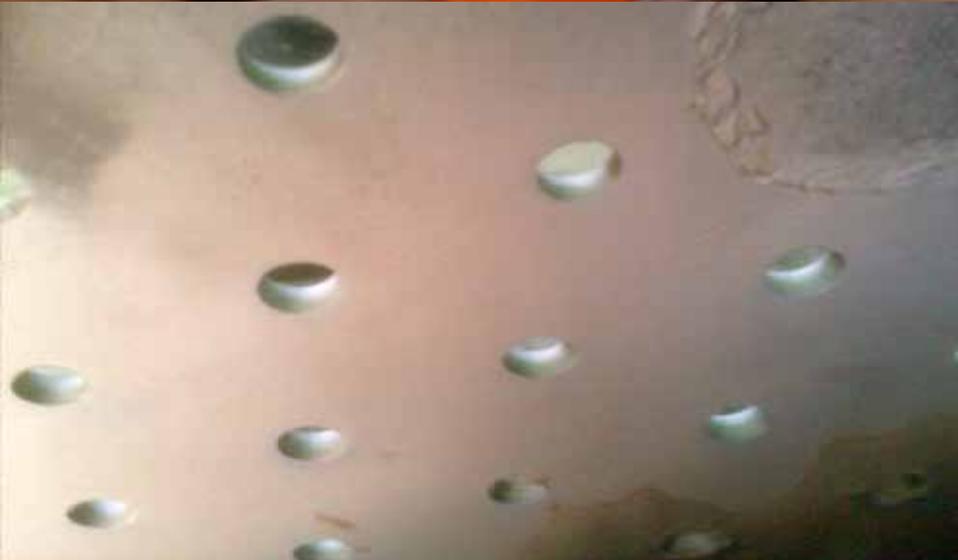
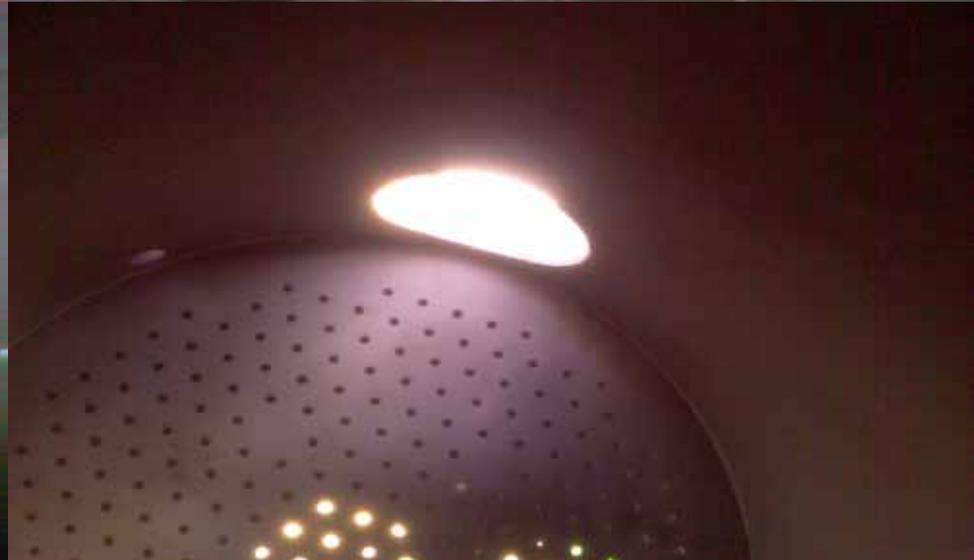
02 - SURFACE PREPARATION

Grid blasting to clean metal Sa2 ½ with profile roughnes min. 50 microns

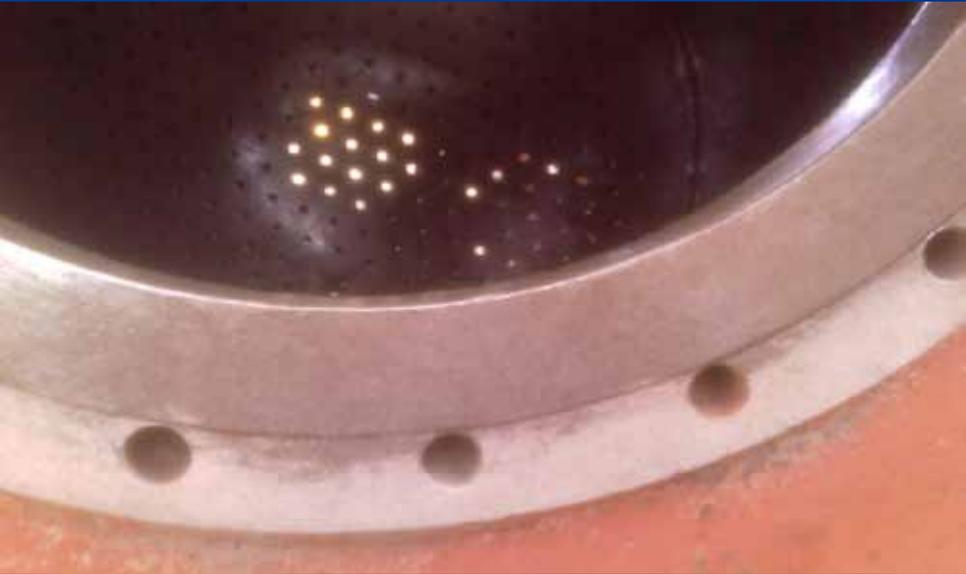
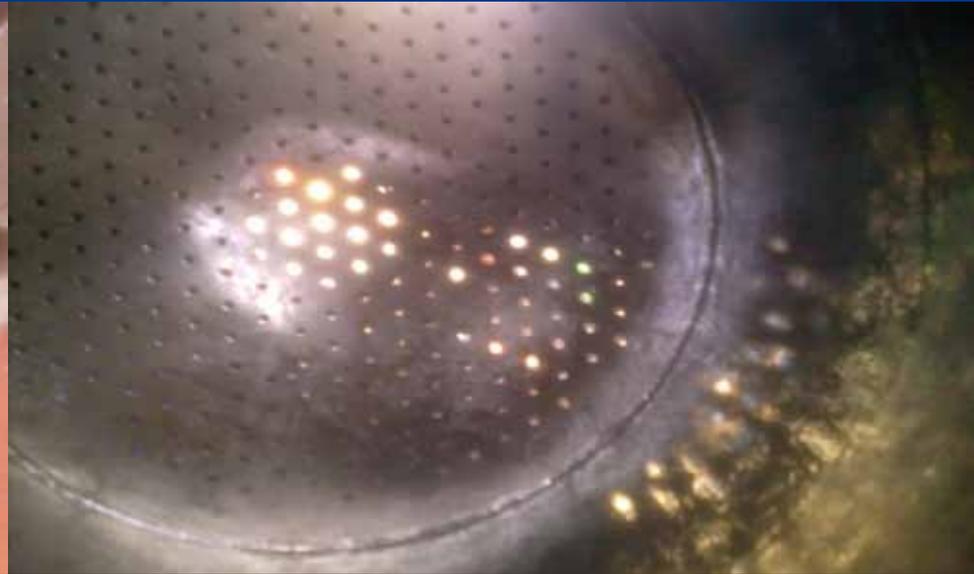
03 - CORROCOAT APPLICATION

Priming by PPA, reparations by CORROFILL

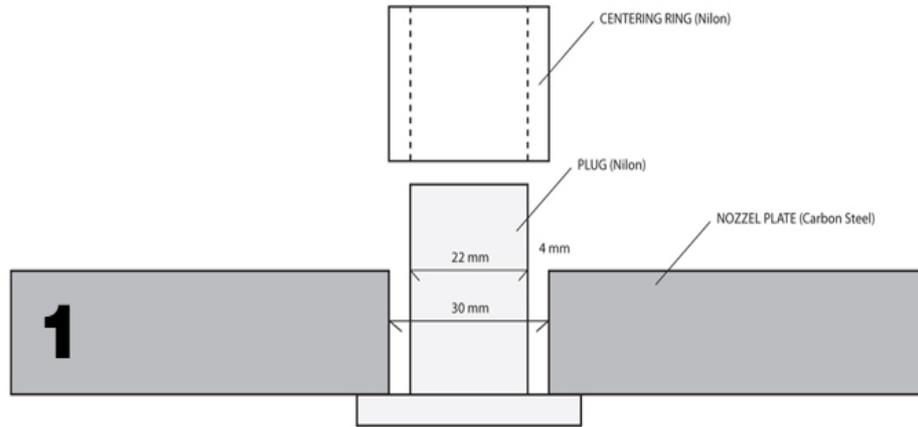
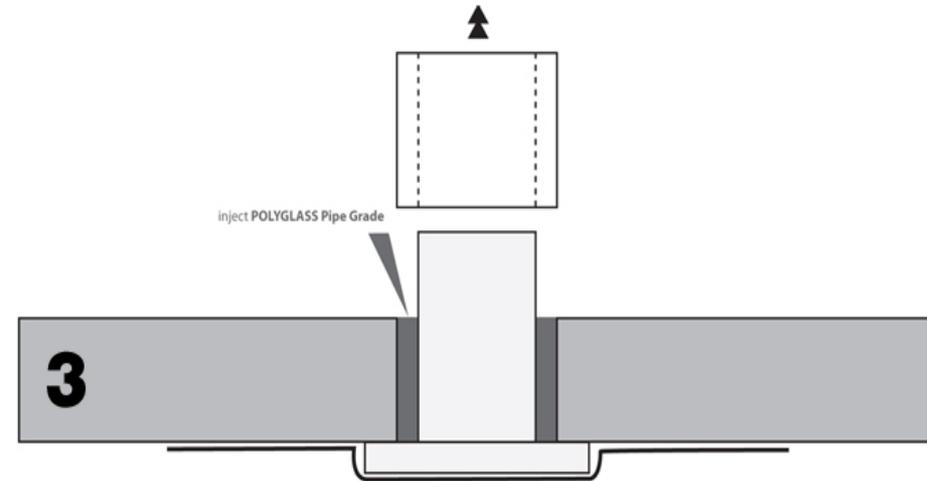
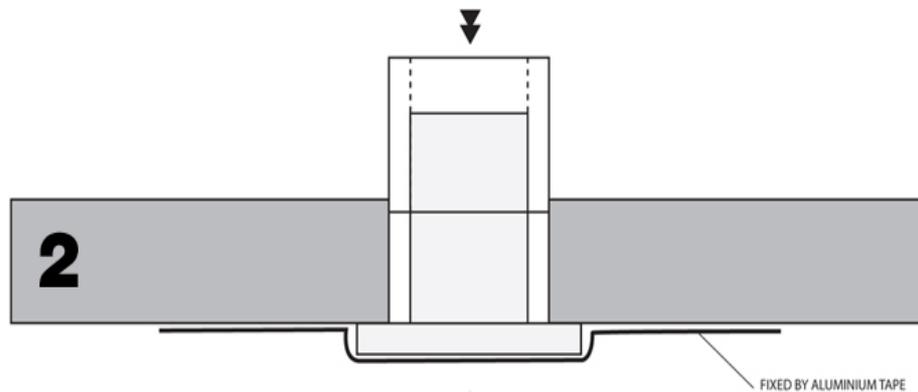
03 - CORROCOAT APPLICATION

Coating method of 296 nozzle holes

Coating method of nozzle holes 2
