CORROCOAT EGYPT - Case study

Internal and external lining of Cation Exchanger Regeneration

Reference No.: 001PG_01_ref_vessel

Client: Amreya Petroleum Refining Company, Alexandria, Egypt

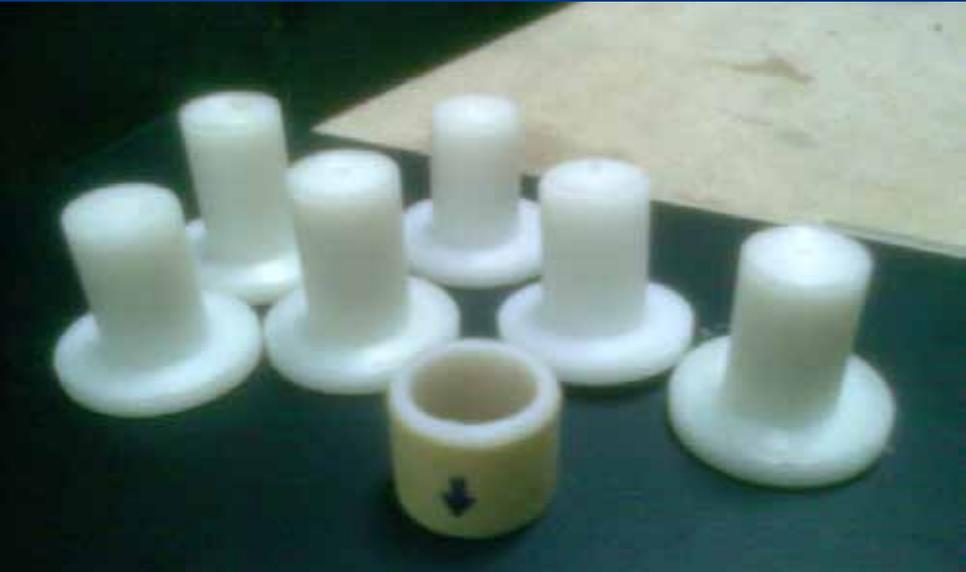
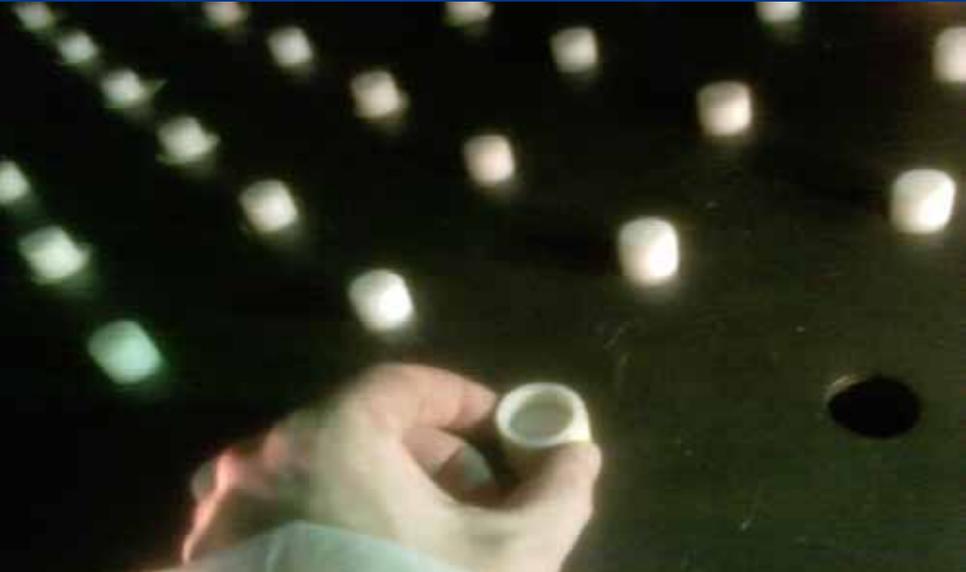
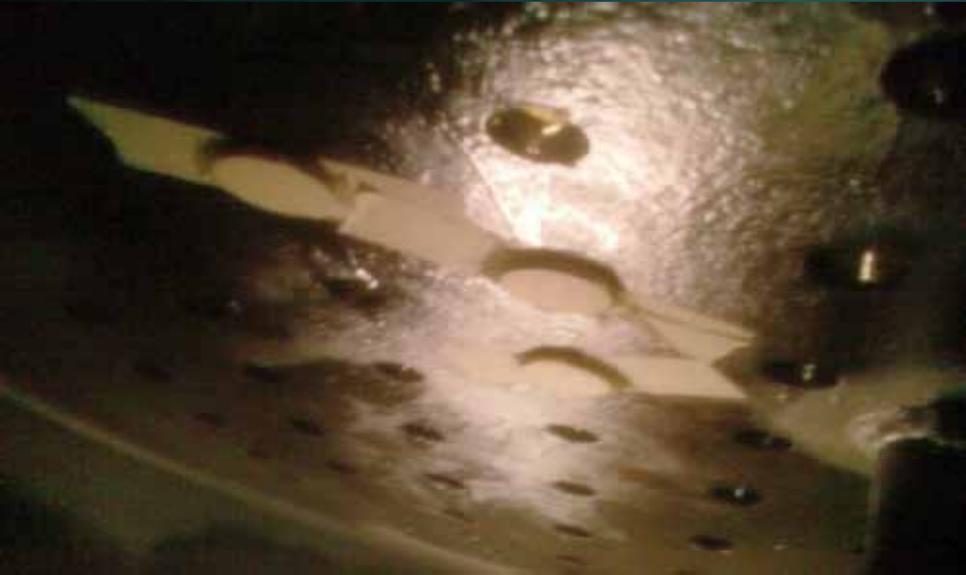
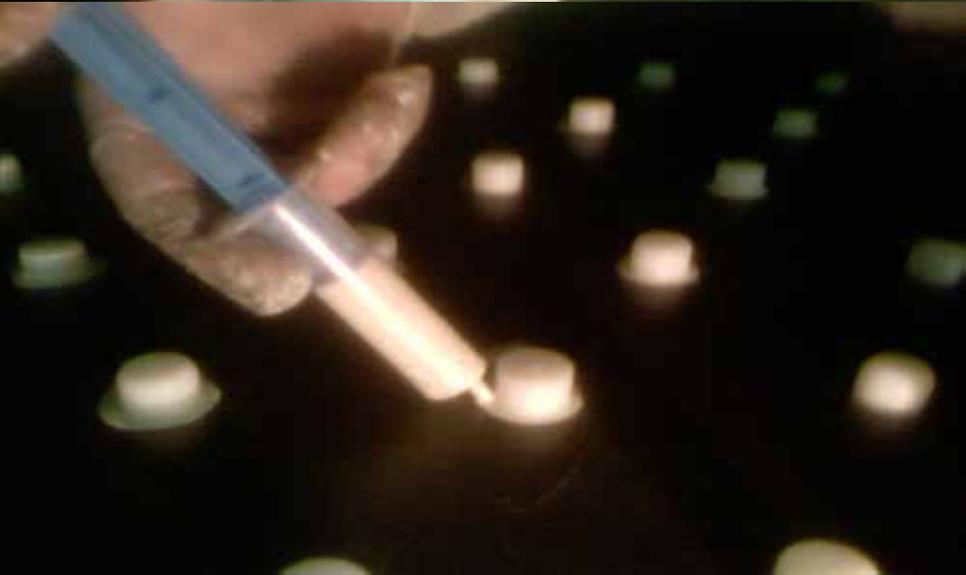
03 - CORROCOAT APPLICATION

Injection coating of POLYGLASS VE PG to 296 nozzel holes

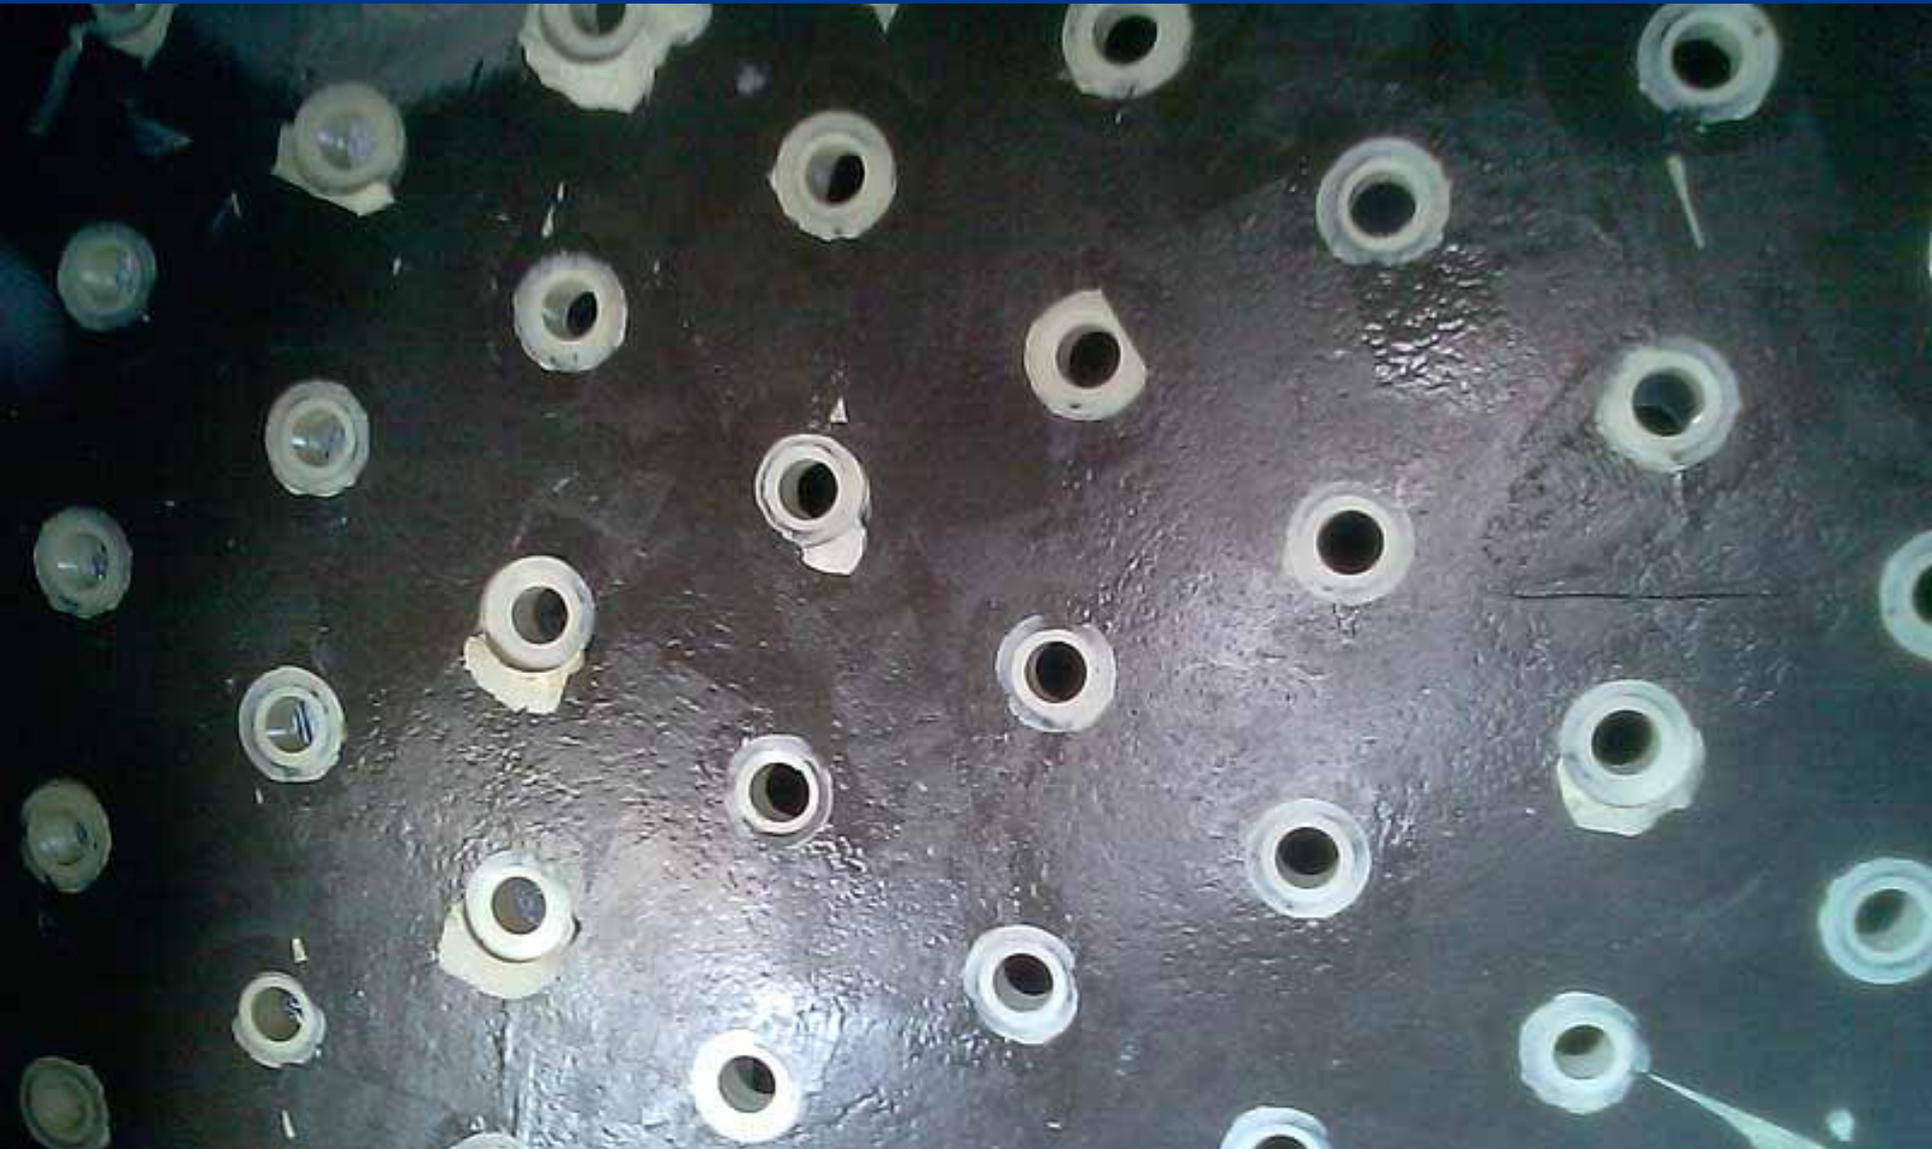
03 - CORROCOAT APPLICATION

vertical surface of 296 nozzel holes coated by 4000 microns of POLYGLAS VE PG

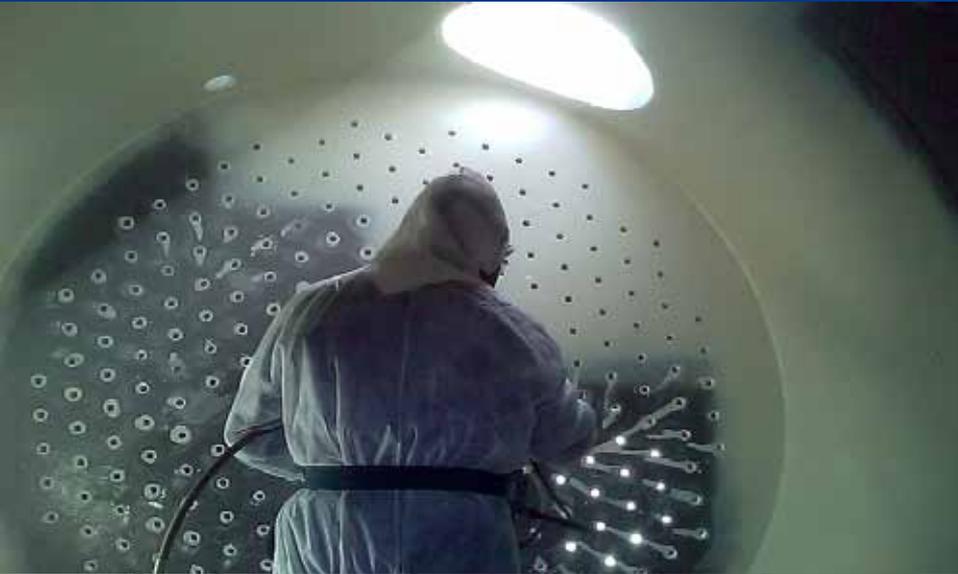
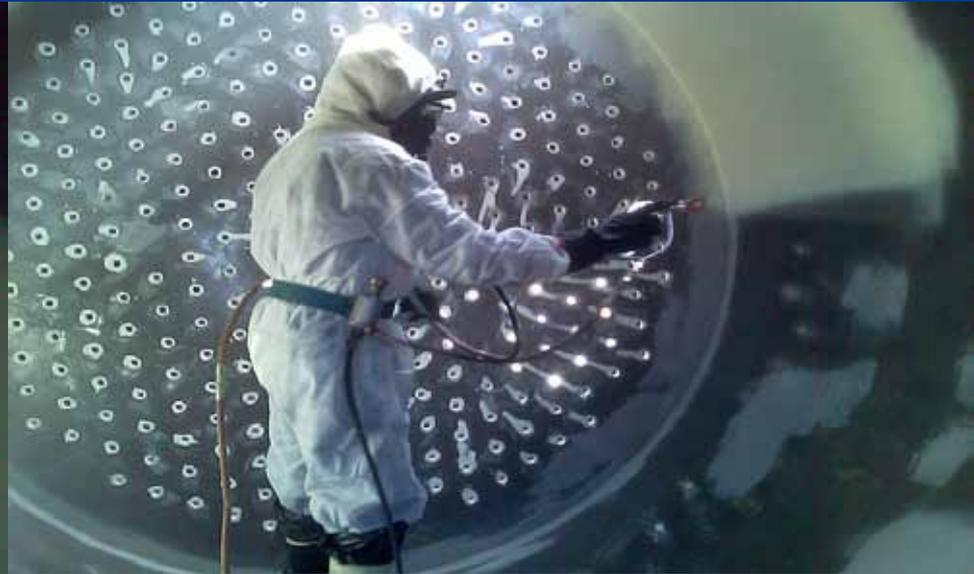
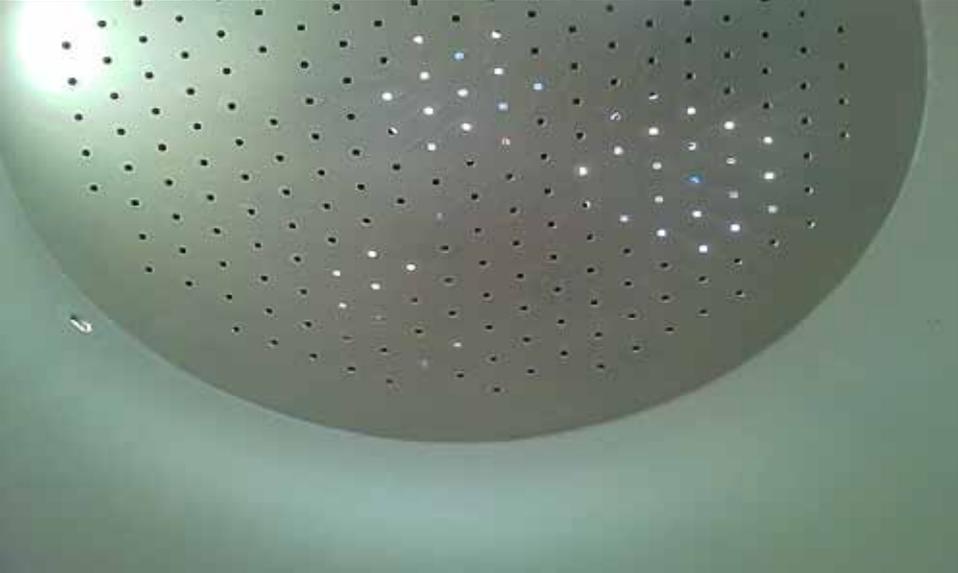
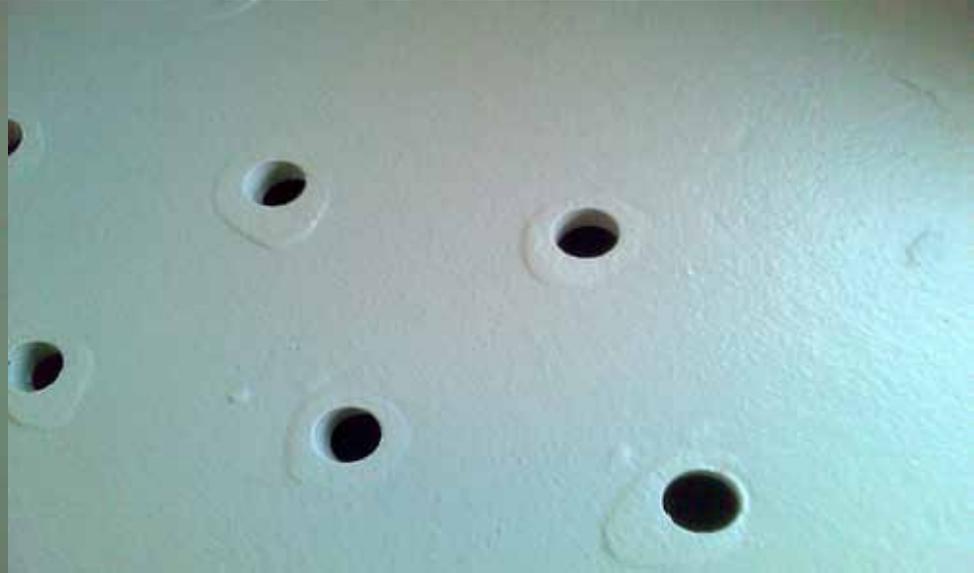
03 - CORROCOAT APPLICATION

Sparying of POLYGLASS VEF

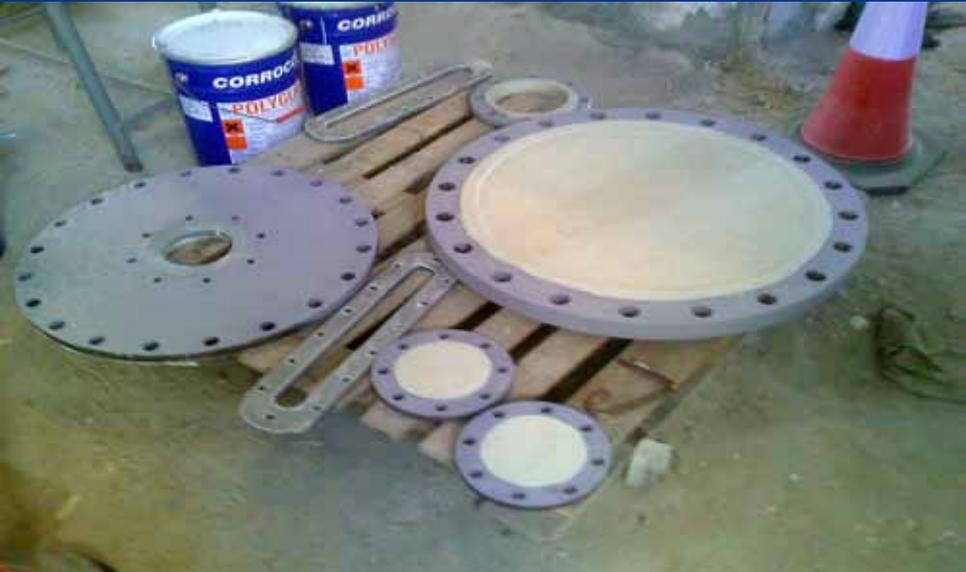
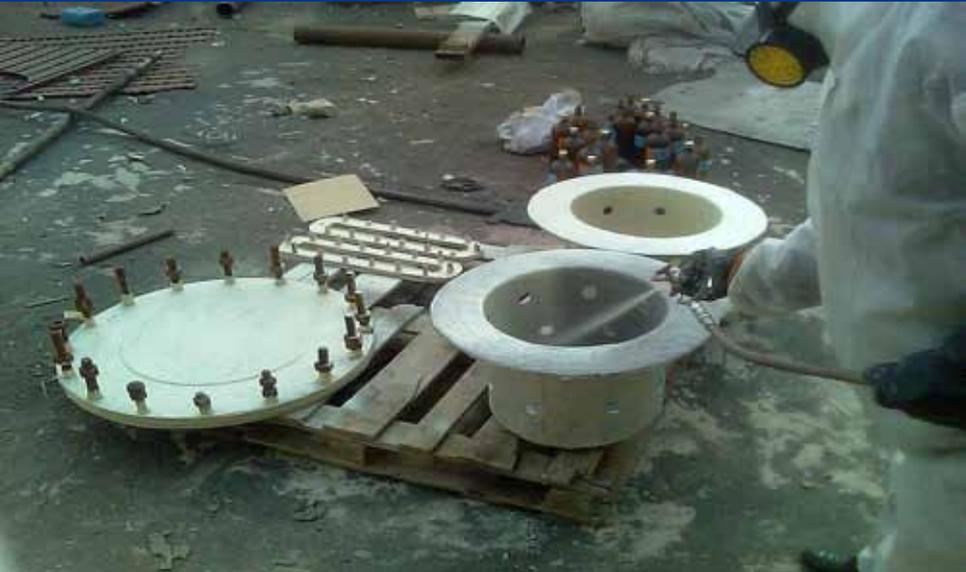
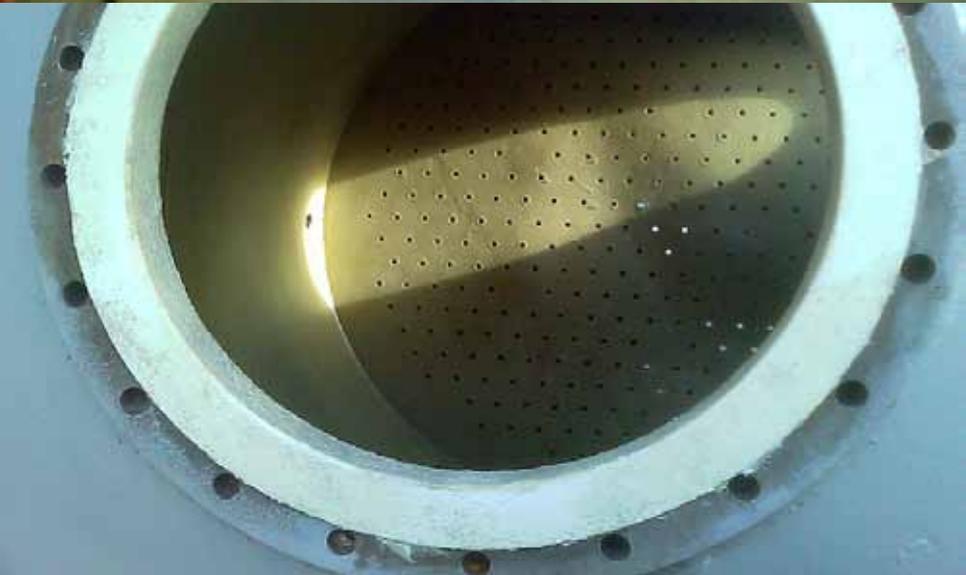
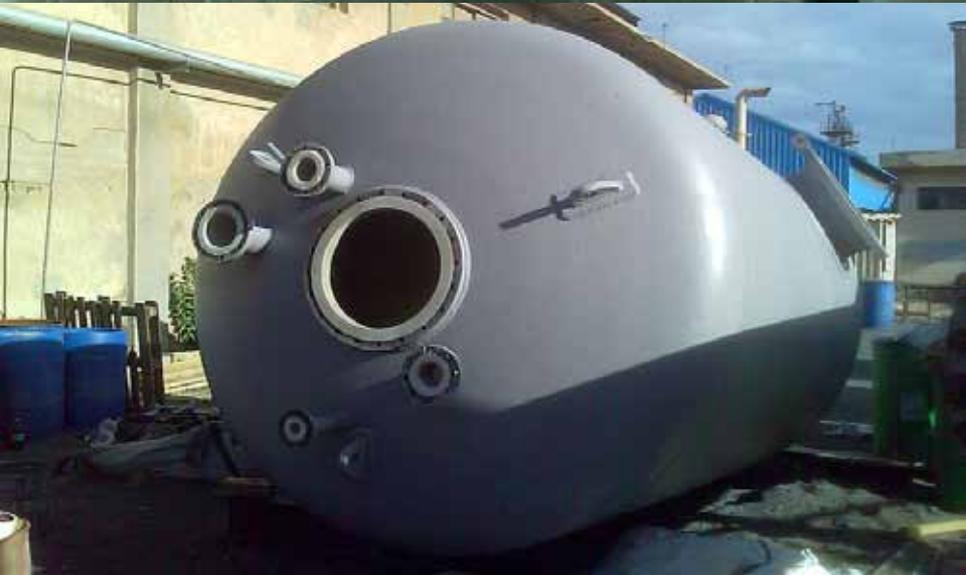
03 - CORROCOAT APPLICATION

Sparying of POLYGLASS VEF to accessories parts and external PLAZMET ZF

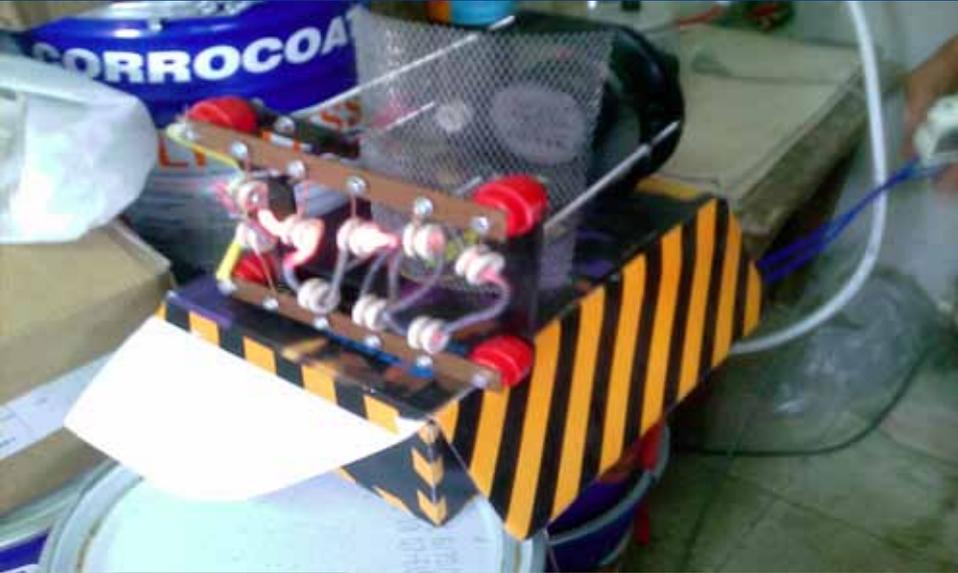
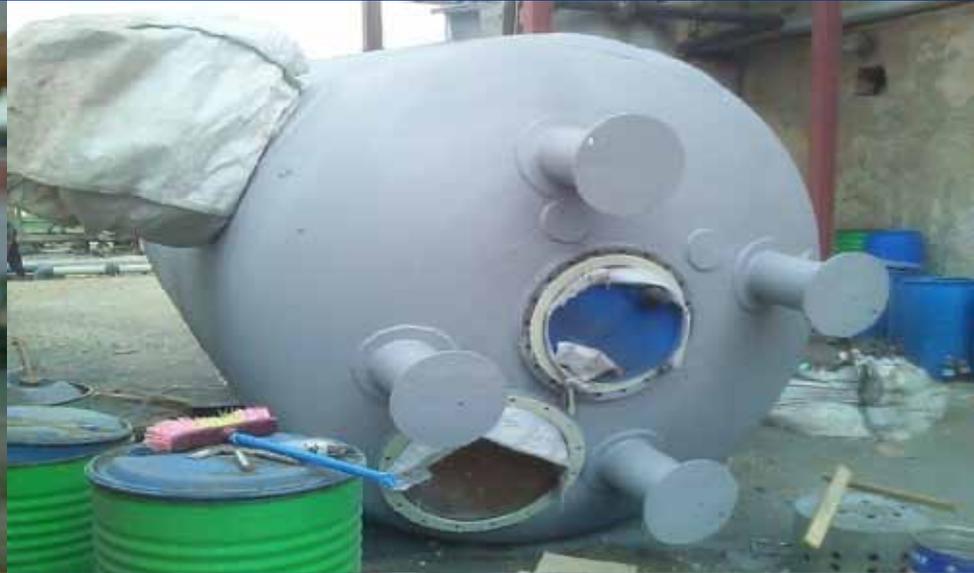
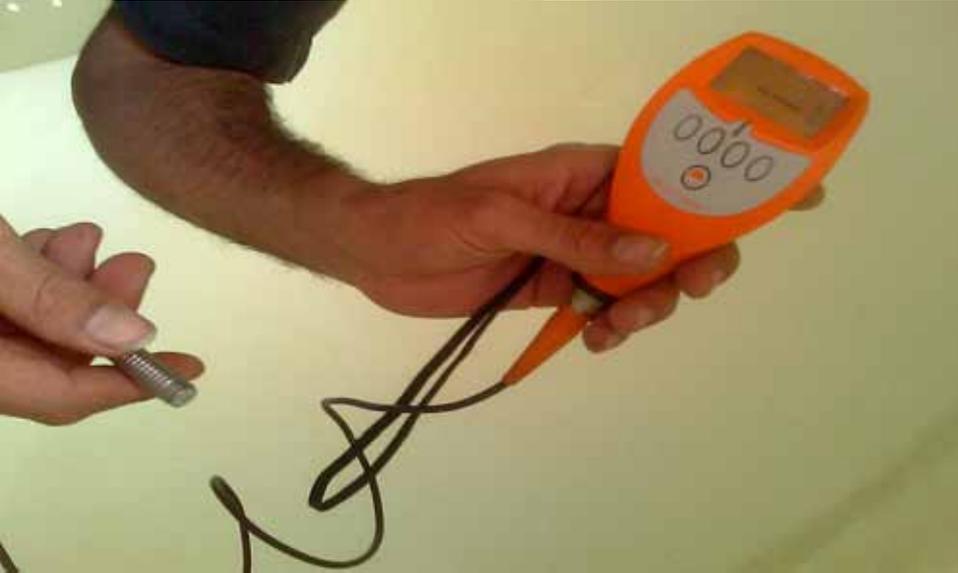
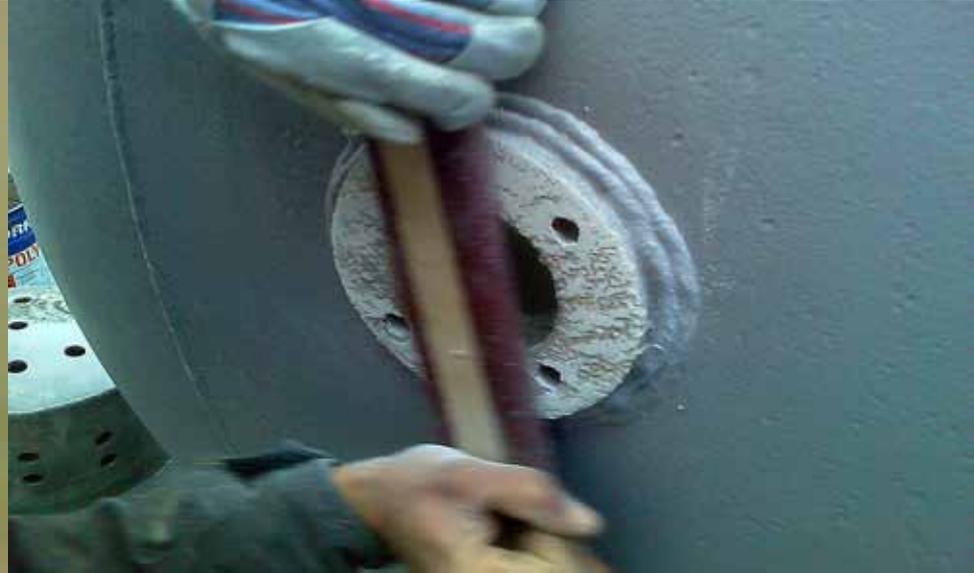
03 - CORROCOAT APPLICATION

Postcuring, DFT test, Spark test, Finishing

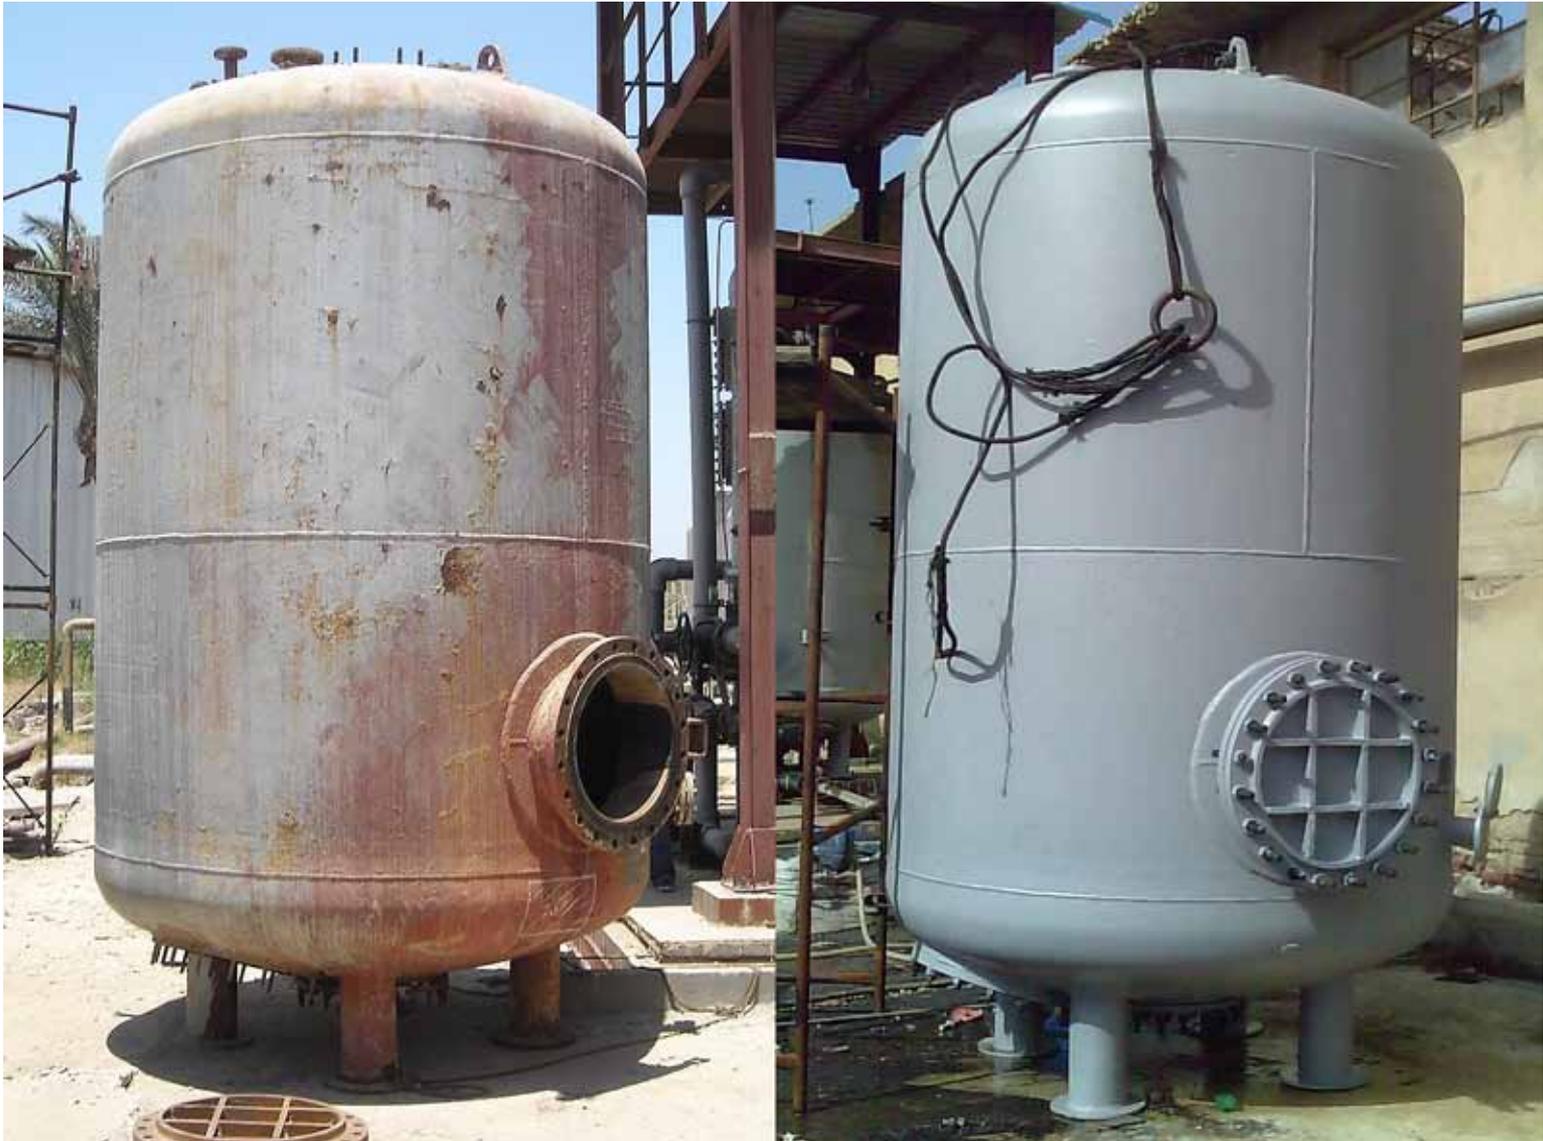
Internal and external lining of Cation Exchanger Regeneration

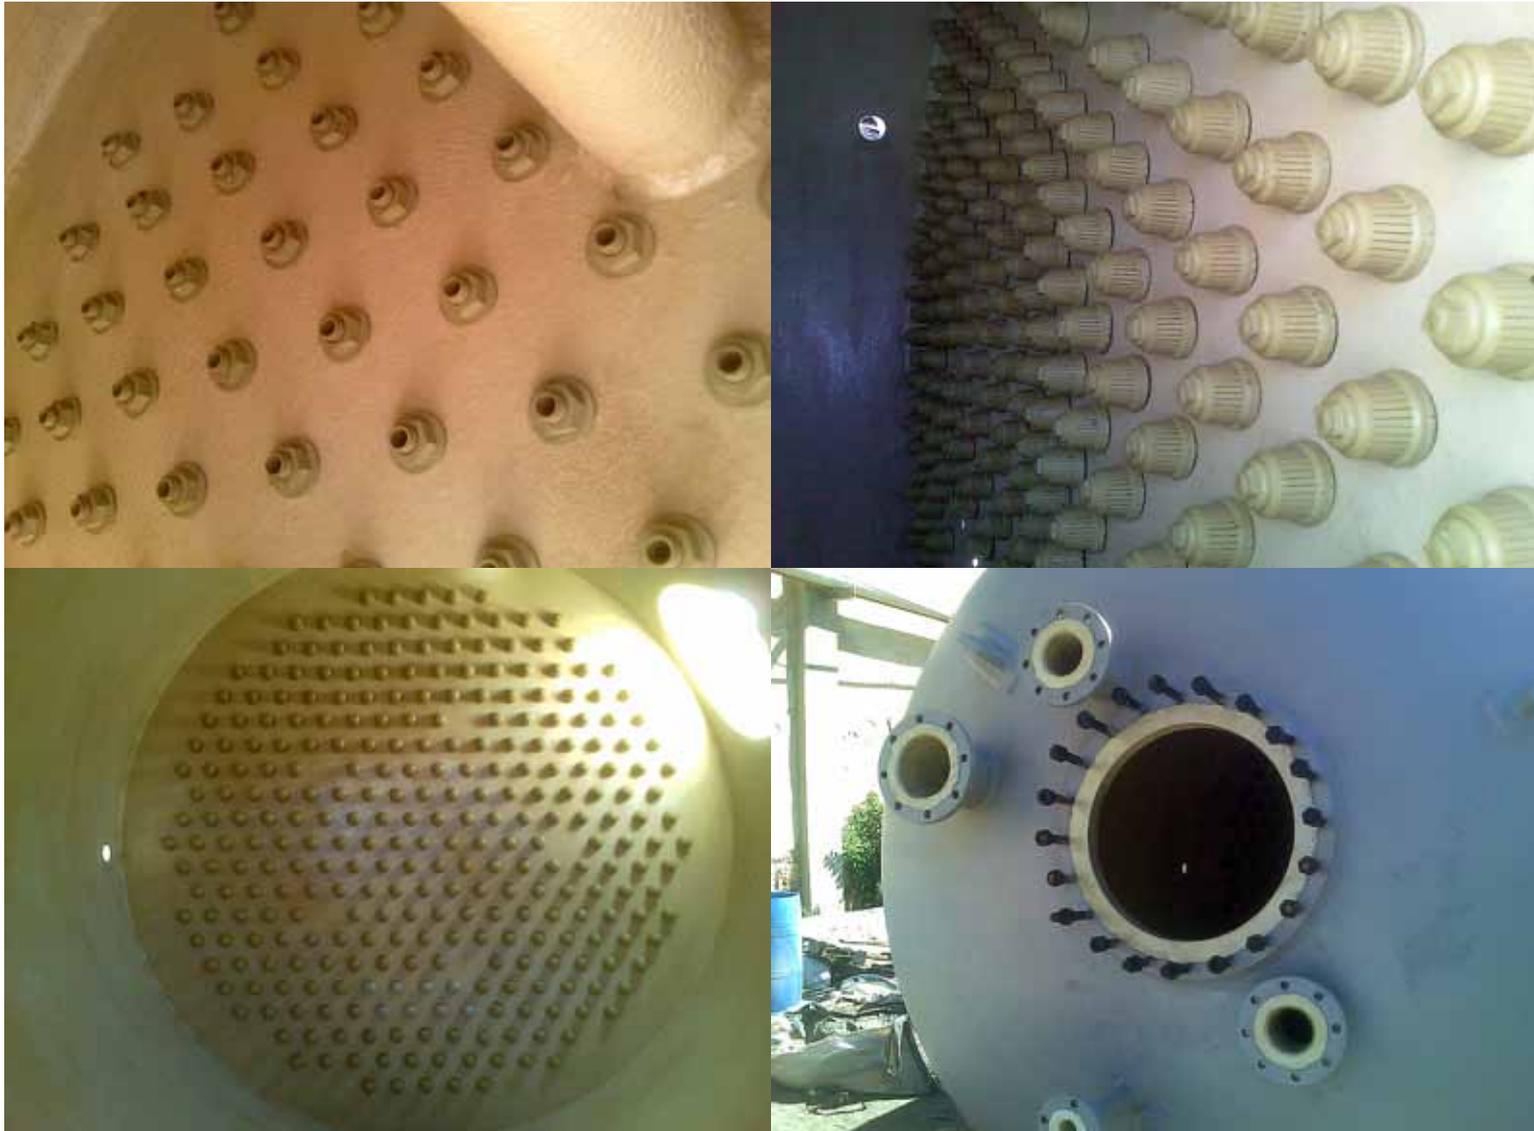
Internal and external lining of Cation Exchanger Regeneration – nozzels inst.

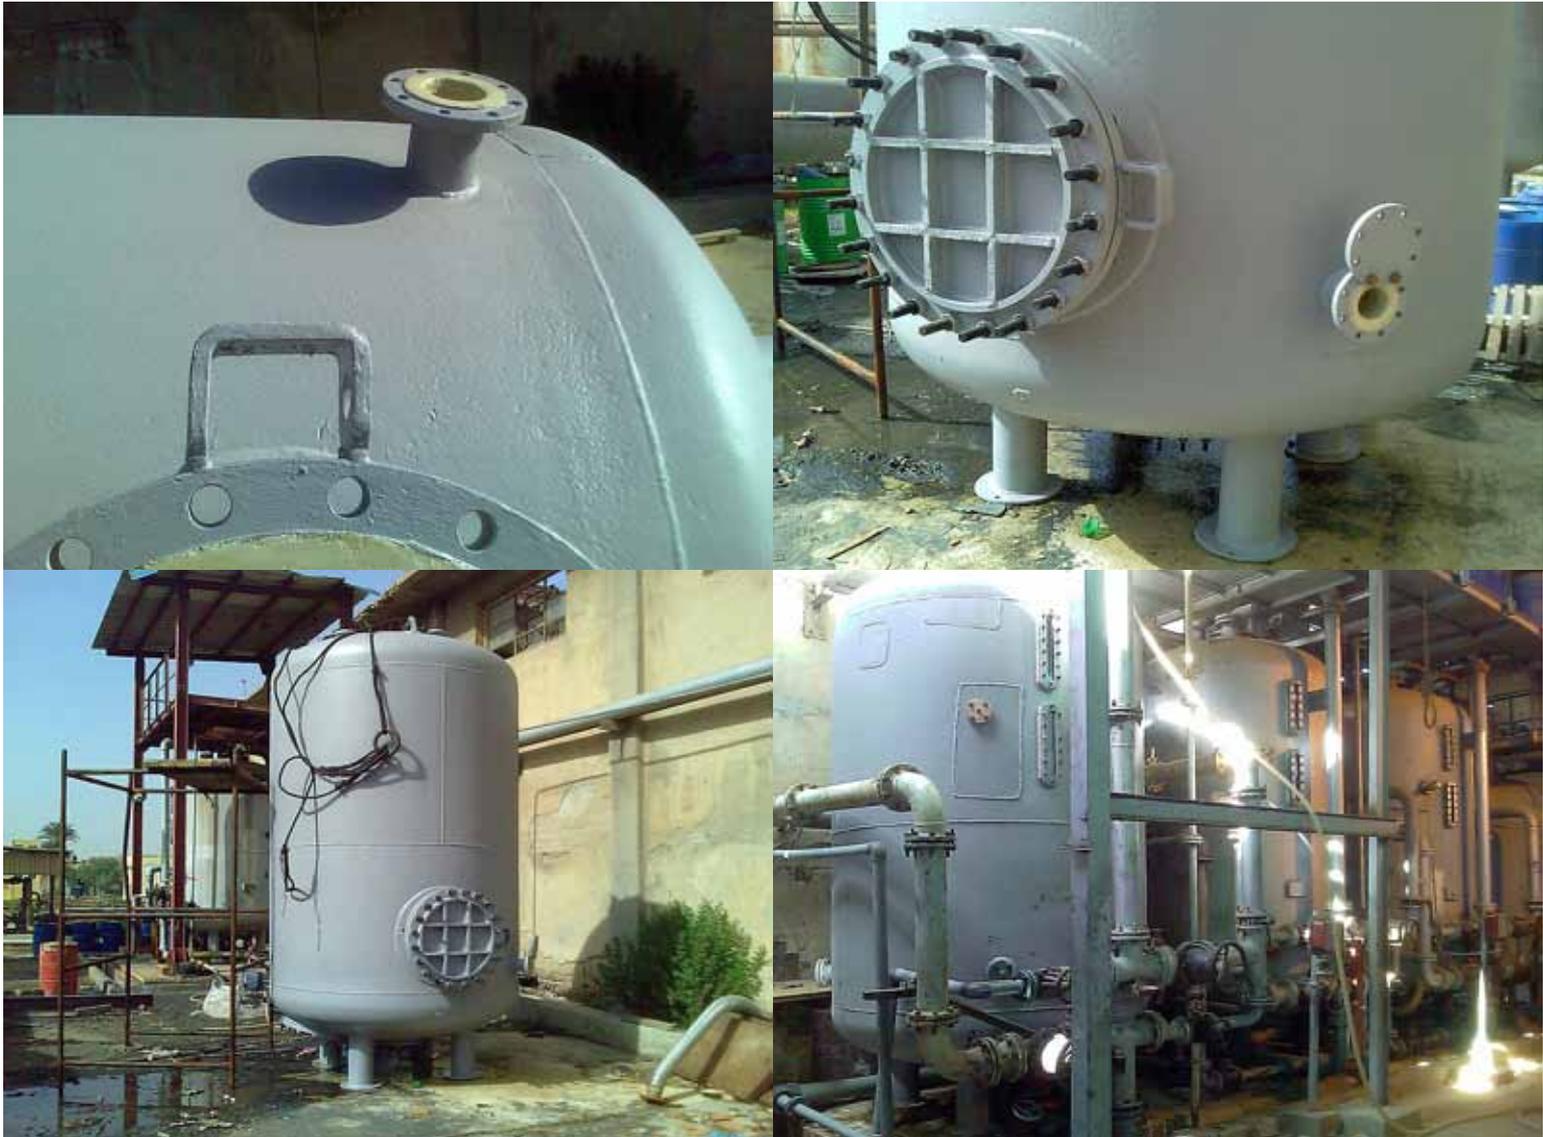
Internal and external lining of Cation Exchanger Regeneration - back in service
